Steigerwald Lake National Wildlife Refuge Habitat Restoration Project Effectiveness Monitoring & Adaptive Management Plan

Lower Columbia Estuary Partnership
September 2021

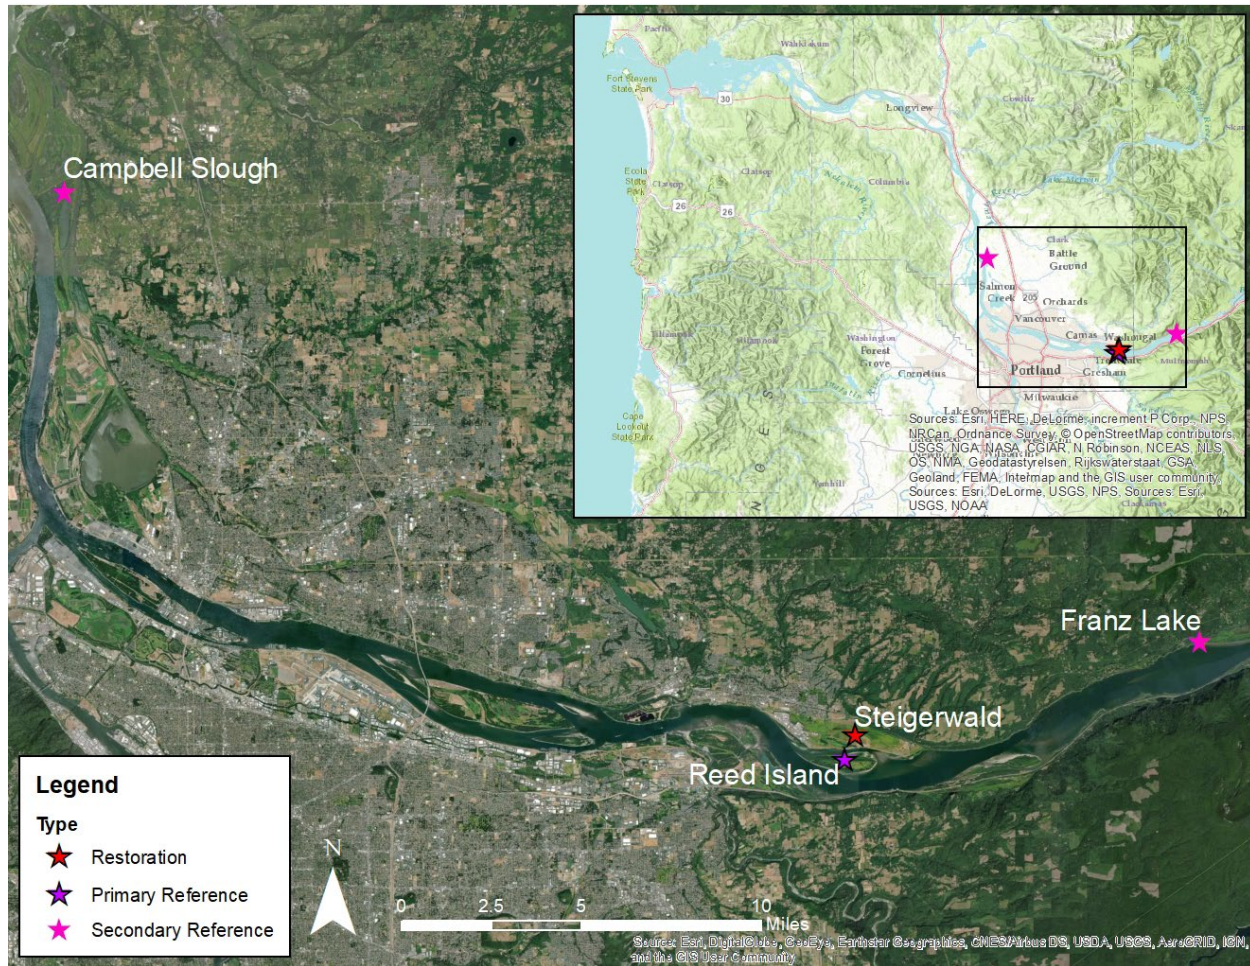
Figure 3: Location of Steigerwald Restoration site and reference sites in the lower Columbia River

Multiple reference sites including long-term Ecosystem Monitoring Program sites Franz Lake and Campbell slough and Reed Island will be used given the variety of expected habitat types following restoration actions focusing on plant community, hydrology, macroinvertebrate communities, and fish (Figure 3). Reed Island State Park will be used as the primary reference due to its proximity to the restoration site and will represent the potential wetland riparian community for this portion of the river. Franz Lake will be used to represent wetland habitat adjacent to the reconnection channels related to beaver activity, which can alter duration and depth of floodplain flooding.

Campbell Slough will be used to represent wetland habitat adjacent to slough channels, which are dominated by a fluvial input with minor tidal effects and will be used to compare fish PIT tag community results (Figure 3). For a full description of these reference sites and their monitoring see Appendix A.

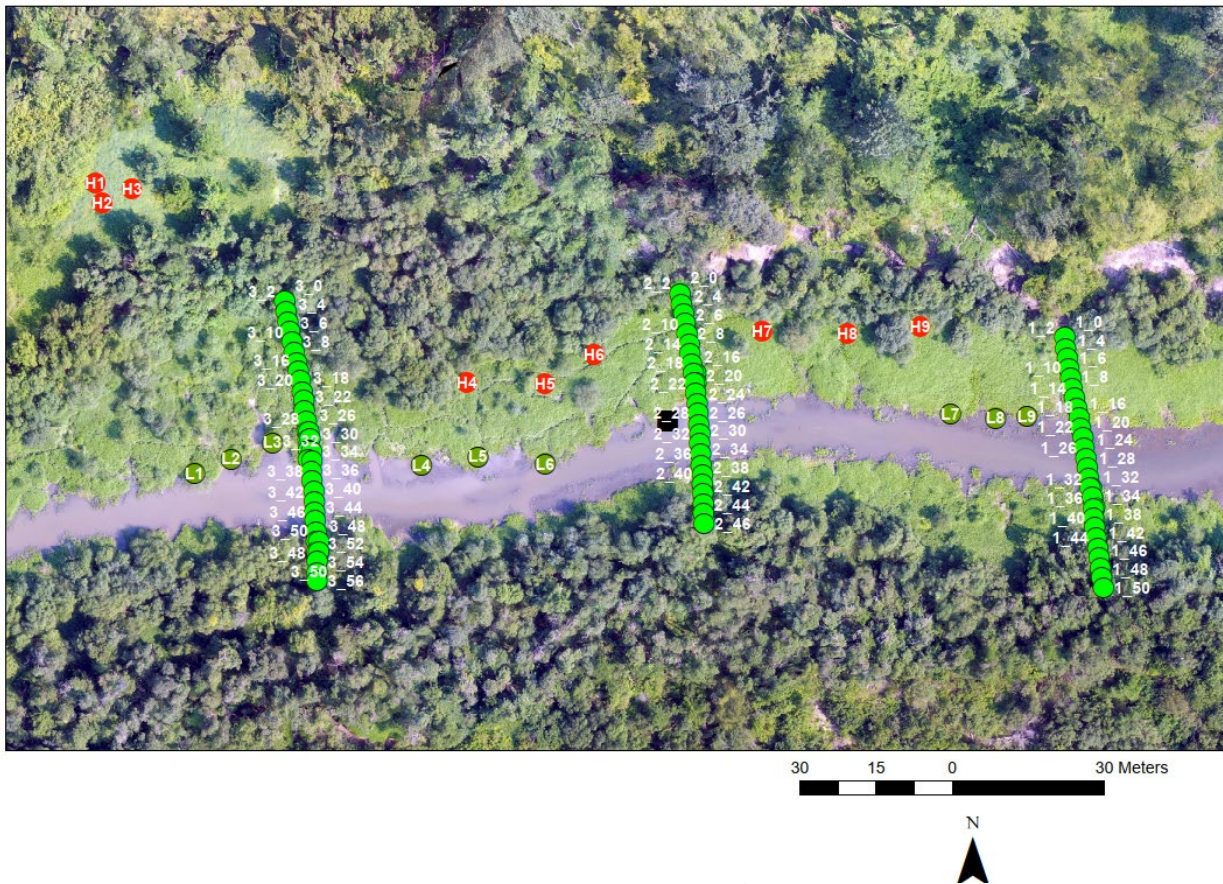
Figure 11: Long-term monitoring design at Franz Lake, light green circles are transect vegetation plots, black is WSE/TEMP data logger location, red and olive green are biomass sampling location in 2020.

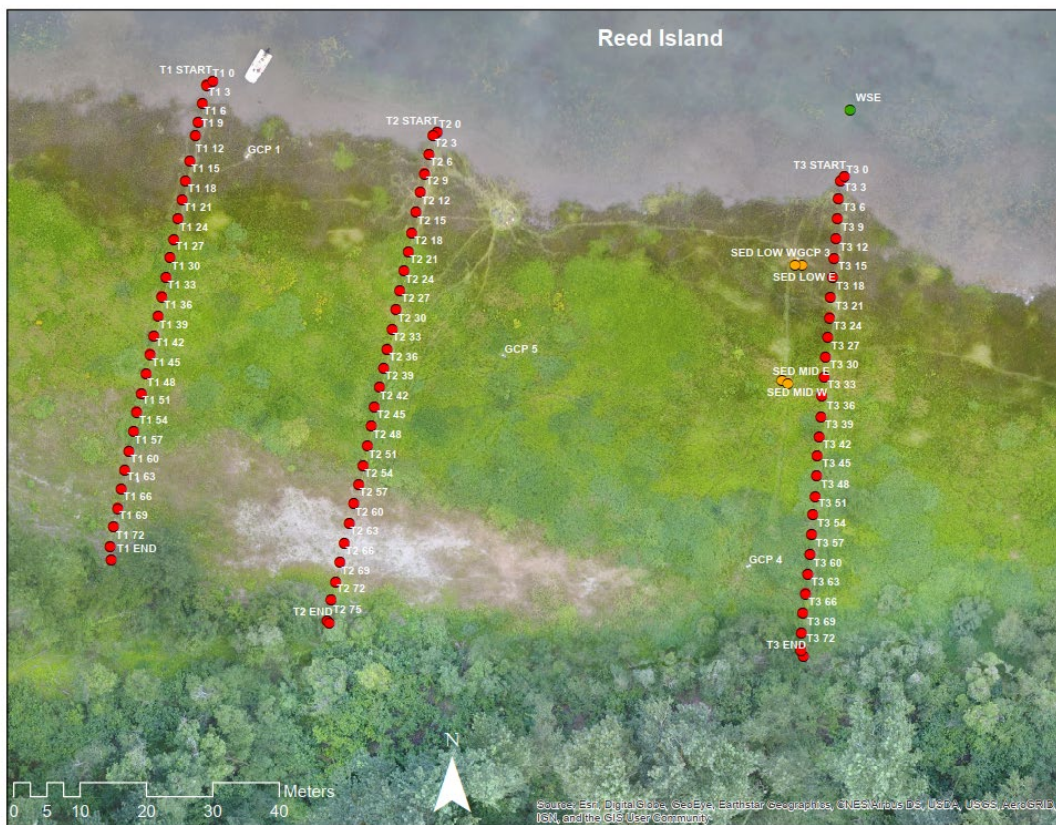
Figure 12: Established monitoring design at Reed Island (2019), red circles are vegetation monitoring plots, orange are sediment accretion benches, and green is the WSE/Temp logger location.

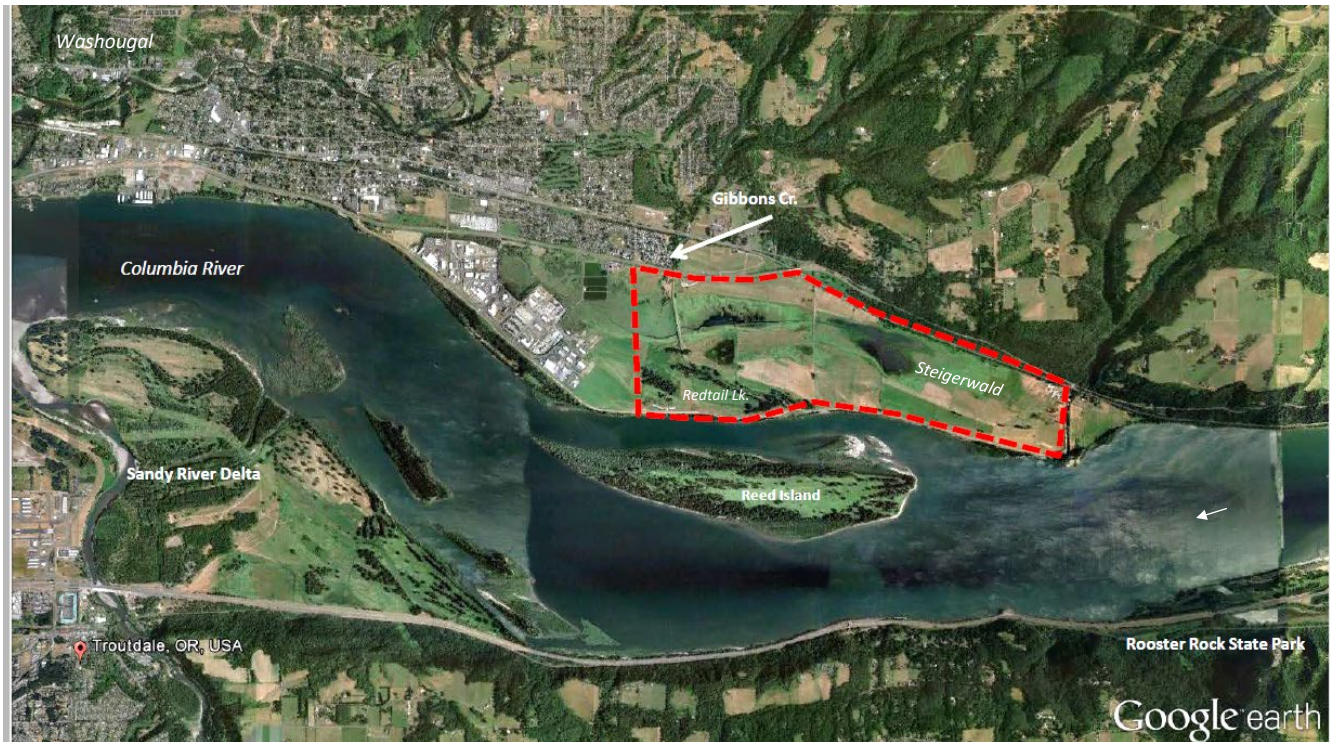
Appendix B Figure 1. Steigerwald project site location.

The 1,049-acre Steigerwald site is located between River Mile (RM) 124-128 along the Columbia River (Appendix B Figure 1). The site is owned by the United States Fish & Wildlife Service (USFWS). The site is currently disconnected from the Columbia River by a levee that surrounds the project area and protects the adjacent Port of Washougal to the west. The site is bounded to the north by Highway 14 and the BNSF railroad and to the South by the Columbia River. A fish ladder at the Columbia River provides access to an elevated channel that transports fish through the Steigerwald site and connects to Gibbons Creek near Highway 14 and in the area of the historic Gibbons Creek alluvial fan. Currently, fish do not have access to visa via the elevated channel to the Steigerwald site except during flood events.

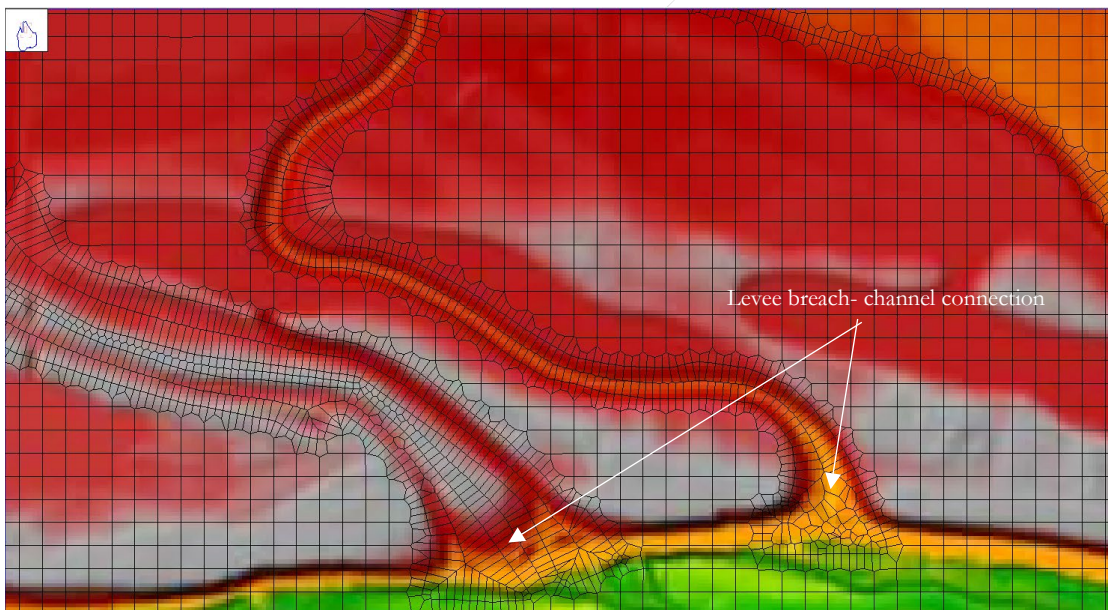
Appendix B Figure 3. Example of model mesh used- resolution was varied from 1 m²-30 m². The smaller mesh resolution can be seen in the levee breach areas and the channels that connect to the wetlands.

- Model geometry included developing a flexible mesh approach and includes 26,349 computational cells across the site. Generally, 30 m² cells were used along Columbia River and Steigerwald floodplain. Cell resolution was a lot higher in the breach/connection channels and Gibbons Creek, including the alluvial fan (Figure 3). In these locations cell resolution varied from 1 m² to 5 m². Geometry also included break lines to separate higher terrain areas from lower terrain.

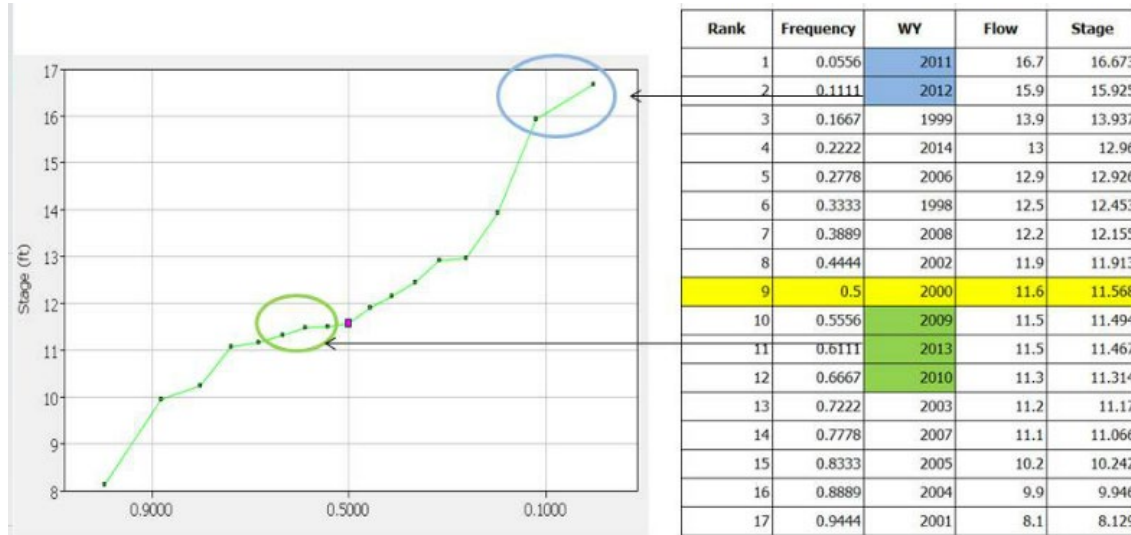
Appendix B Figure 5. Weibull analysis using daily average stage during the growing season at the Vancouver, WA gage (USGS) from 1999-2014. The years 2009- 2013 are highlighted to show overlap with data from Franz Lake. Overall, 2009 is close to the mean stage of 11.6 (NAVD 88 ft.).

analysis (Figure 5), we chose 2009 to represent “average” conditions at Franz Lake and relied on 2009 data collected at Franz Lake.

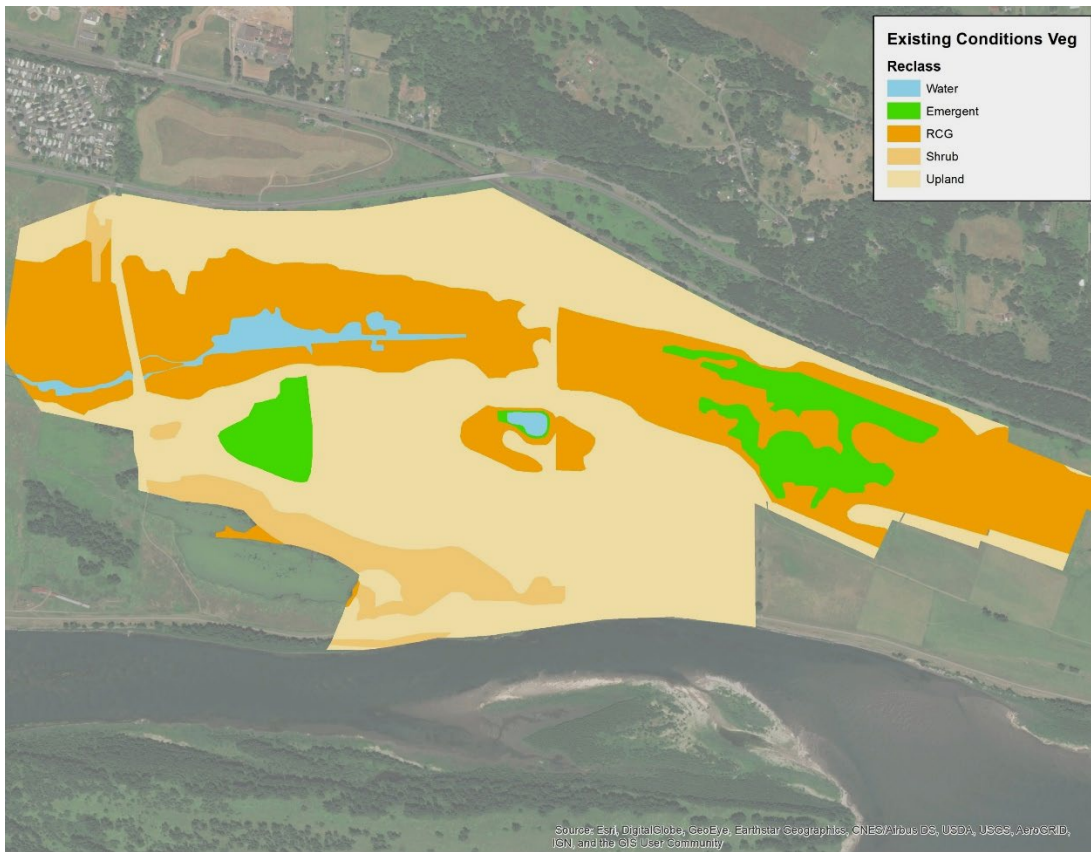
Appendix B Figure 6. Existing plant communities at Steigerwald.

Figure 6 below shows the results for existing conditions related to plant communities. These results below omit Redtail Lake as part of the analysis. This was done, in part, due to the fact that under restored conditions the 2-year flood does not effect Redtail Lake. The existing plant communities include: open water- 32 acres, emergent- 47 acres, reed canarygrass/shrub- 308 acres and upland- 367 acres.

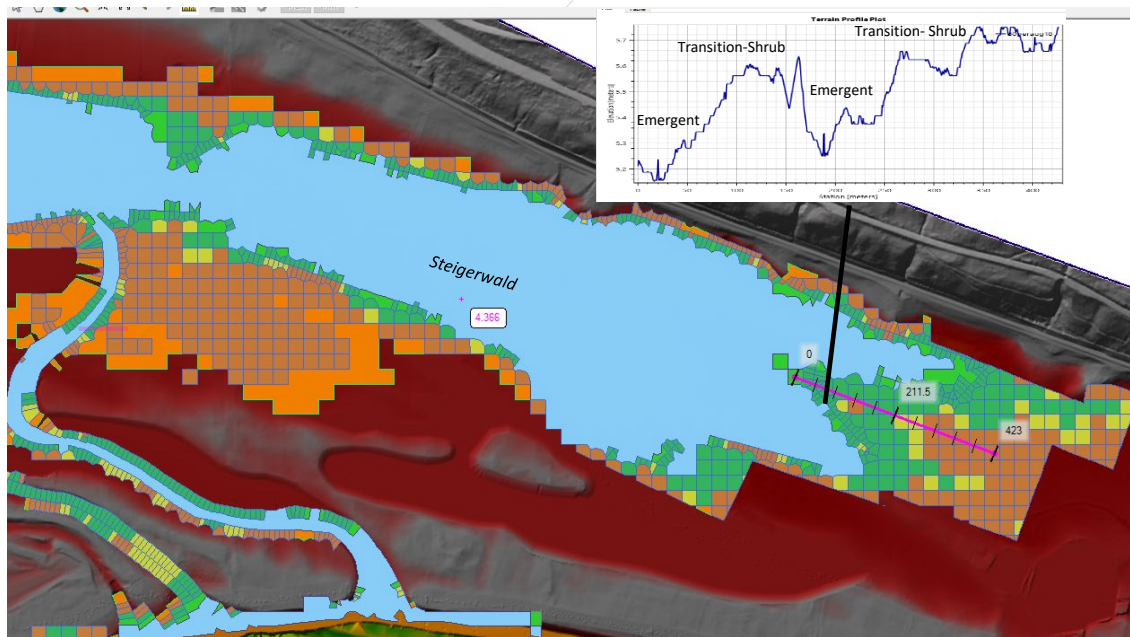
Appendix B Figure 9. Cross-section at the eastern most portion of the restoration site. The cross section inset shows the differences in plant communities as the elevation and site inundation change. The lower areas favor emergent vegetation, while the higher areas are dominated by shrubs as well as the potential for reed canarygrass.
