# **Action Effectiveness Monitoring for the Lower Columbia River Estuary Habitat Restoration Program**

**BPA Project Number: 2003-007-00**  
**Report covers work performed under BPA contract # 80237**  
**Report was completed under BPA contract # 90999**  
**Performance/Budget Period: October 1, 2021 – September 30, 2022**

## **Action Effectiveness Monitoring for the Lower Columbia River Estuary Habitat Restoration Program Annual Report (October 2021 to September 2022)**

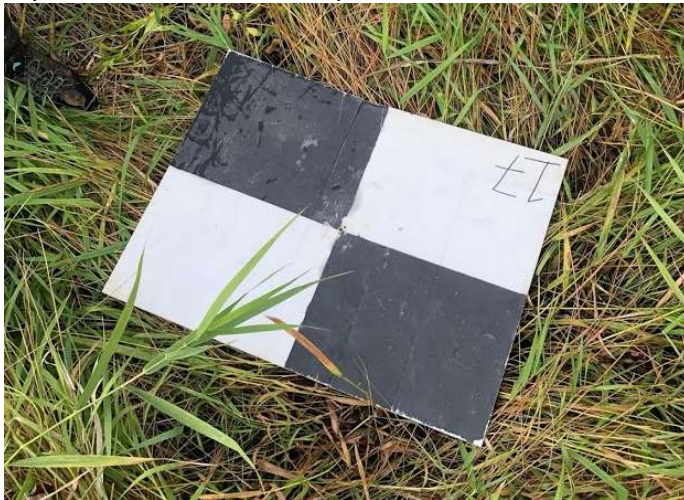
Figure 8: 1m x 1m rectangular ground control point (GCP)

A DJI Phantom 4 was outfitted with a Sentera Near Infrared (NIR) Camera was the UAV chosen to collect multispectral aerial images (visible or RGB, and NIR) of the restoration sites. At each site, Pix4D capture was used to create the flight polygon grid with overlaps of 80% fore-lap and 80% side-lap. The UAV was flown at 300ft above ground level (AGL), producing a high density of images (ground sampling distance (GSD) of 1.68 inches per pixel). Multispectral data was collected between 11 am and 12 pm to ensure consistent light conditions at all sites. Ground control points (GCPs) were placed at sites and surveyed to geo-reference the aerial images. Between 5 to 10 GCPs were placed at each site, depending on the range of terrain elevations at the sites. The GCPs were 1m x 1m, black and white rectangular cardboard cut-outs; the position and elevation of each were captured using a TOPCON Real Time Kinematic (RTK) GPS. Elevations of different vegetation communities were also collected to outline representative dominant plant communities on the site.

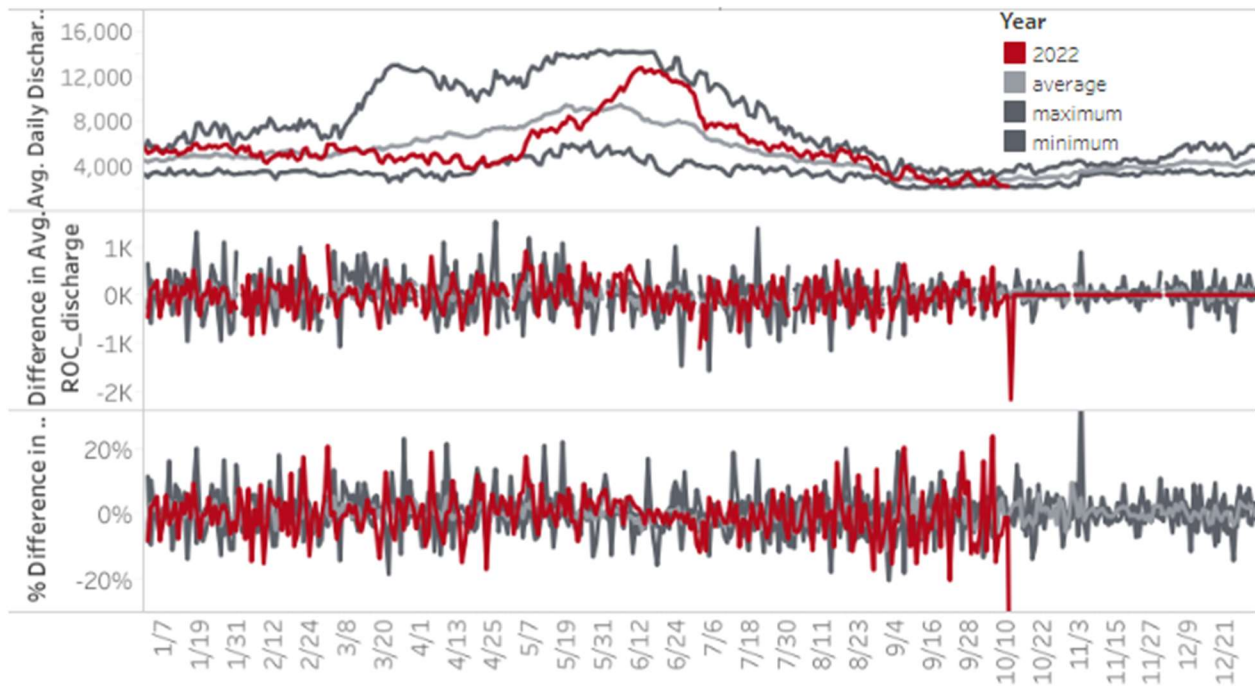
Figure 11. 2022 flows at Bonneville Dam shown in Red, as compared to 2009-2022 min, max and average flows. Top panel shows daily discharge, middle panel show changes in daily discharge and bottom panel shows percent difference in daily discharge.

close to the long-term maximum, observed in 2017. The decline in river discharge following peak flows was steeper than in 2017, but flow remained above average through the end of August after which they were close to the long-term average. River discharge associated with the Willamette was higher than average during a few peaks in winter and spring (early January, early March, early May, and early June) and was otherwise close to or below average values observed between 2009-2022”

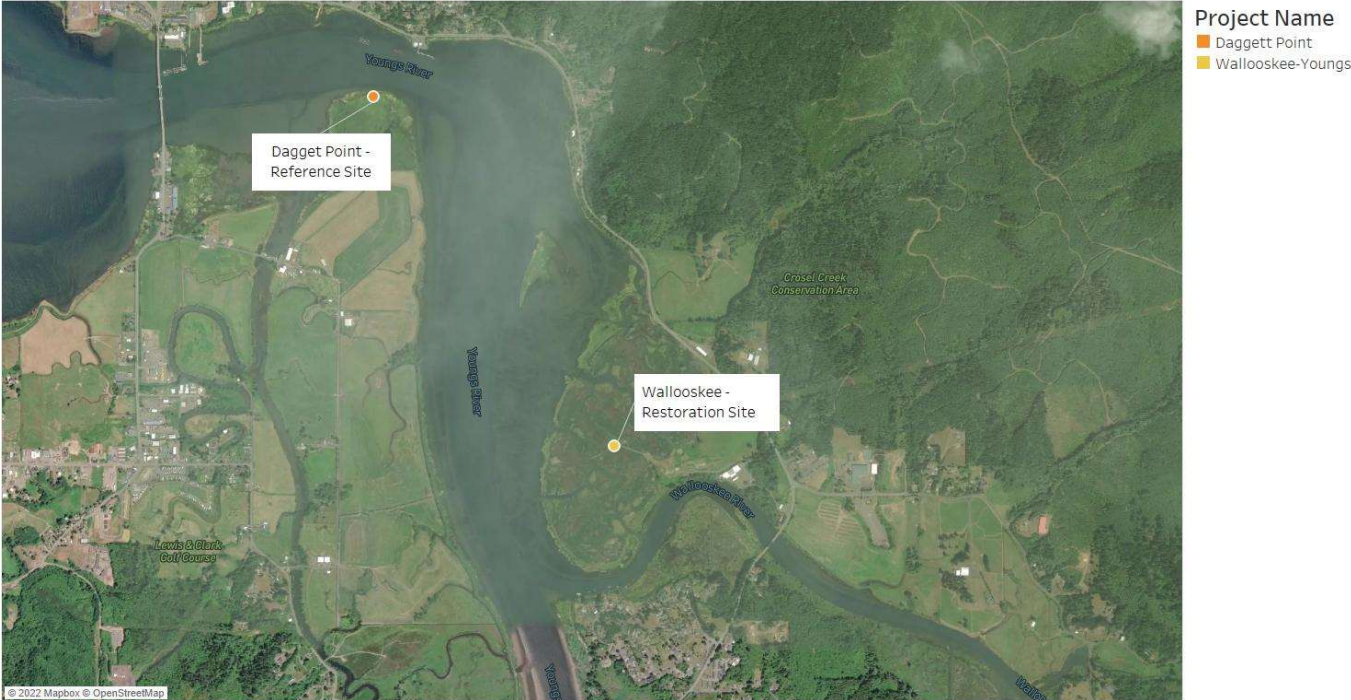
Figure 12: Wallooskee - Youngs Restoration Project Overview Map, depicting the locations of Wallooskee wetland and reference Dagget Point.

Wallooskee - Youngs Restoration Project Overview Map

In 2017, this monitoring effort was transitioned into the BPA AEMR monitoring format, and vegetation grids were added in two areas within the site. One focal plant community monitoring area was in the "North" of the site near a channel re-connection with Youngs Bay, and the other was located on the "South" portion of the site near a channel re-connection with the Wallooskee River (Figure 13, Figure 14). Additionally, Dagget Point was included in the monitoring effort as a nearby un-impacted reference site (Figure 12).

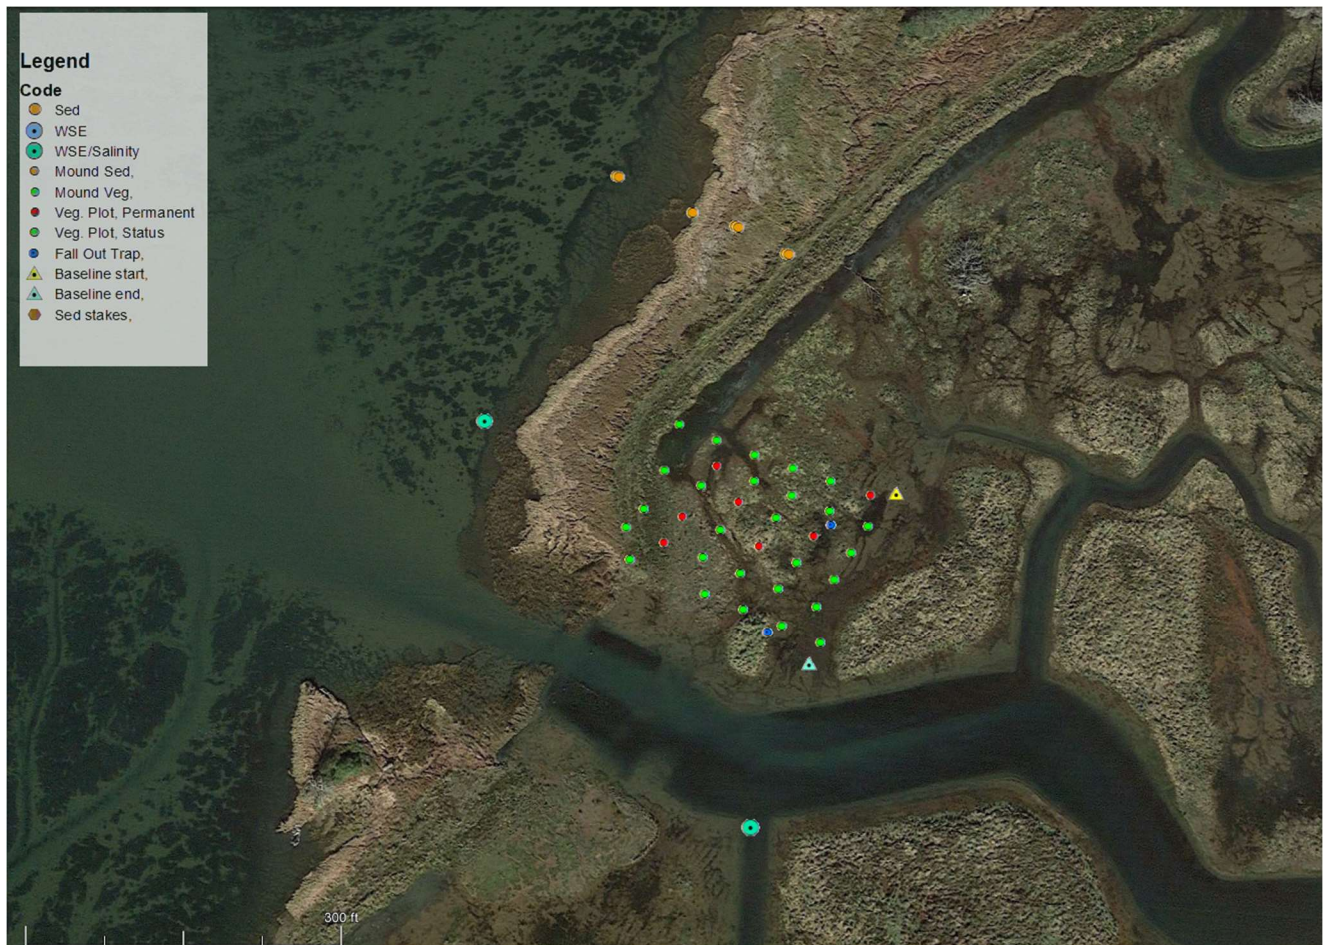
Figure 13: Map of "North" Sampling area at Wallooskee. Map shows vegetation grid and fall-out traps deployed during years 0 and 1. For years 4 and 5, the Macroinvertebrate sampling method was changed to neuston tows.

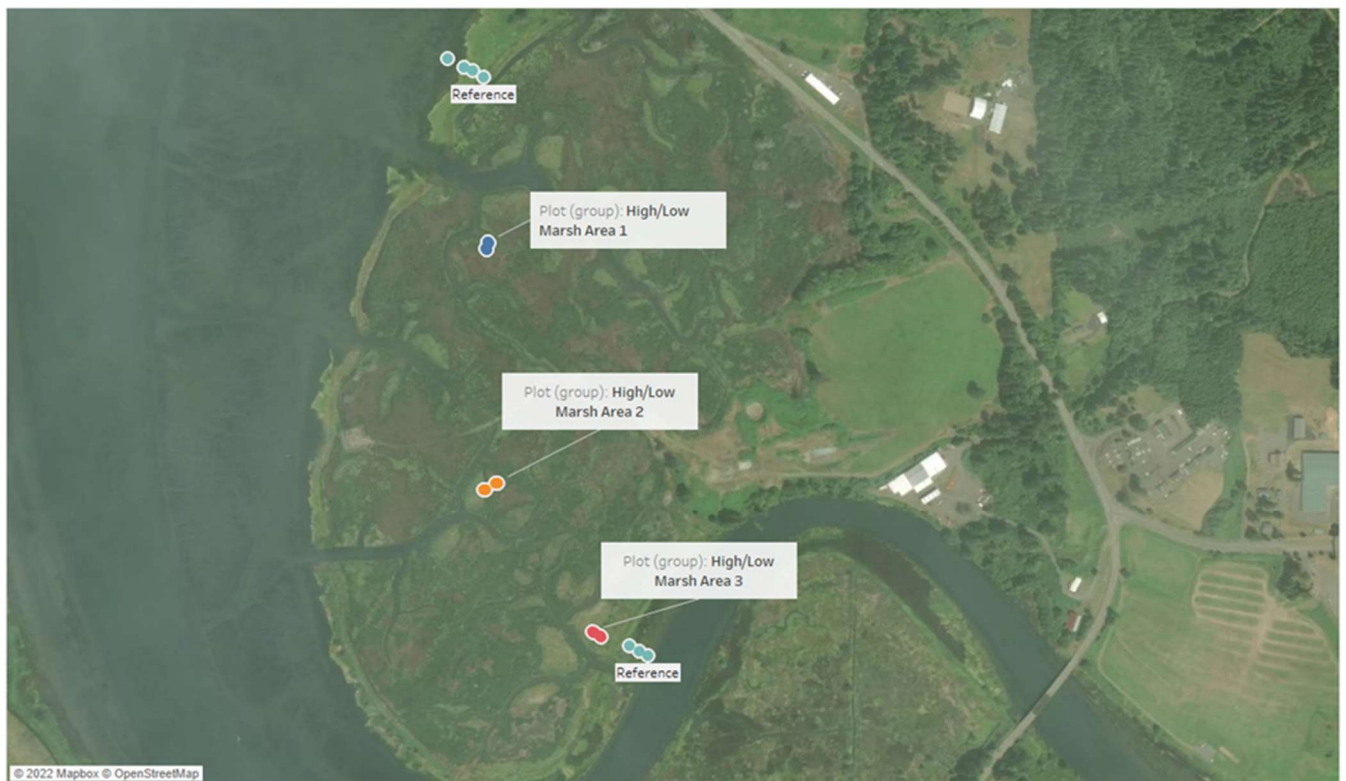
Figure 15: Overview Map showing locations of high and low marsh monitoring areas.

In addition to the BPA AEMR plant community monitoring, three high and three low marsh monitoring areas were established to evaluate how plant communities, soil conditions, and sediment accretion/erosion dynamics varied specifically between these two different constructed elevation ranges (Figure 15). Previous research on tidal wetland restoration in Young Bay (Kidd 2017) has noted a lag in high marsh recovery across restoration sites in the region. Directly monitoring these outcomes at Wallooskee provided an opportunity to further investigate this hypothesis and the mechanisms driving these potential outcomes. Additionally, understanding how topographic mounding influences the trajectory of restoration sites has been identified as a critical uncertainty in the lower Columbia River through the CEERP program (Diefenderfer et al. 2016).

In this study, the high marsh monitoring areas were situated in areas that were mounded to create high marsh conditions during restoration and paired with nearby low marsh zones to capture similar flooding dynamics (between the high and low marsh zones) across the site. Based on previous literature and data collected at the site (Kidd 2017), it was generally

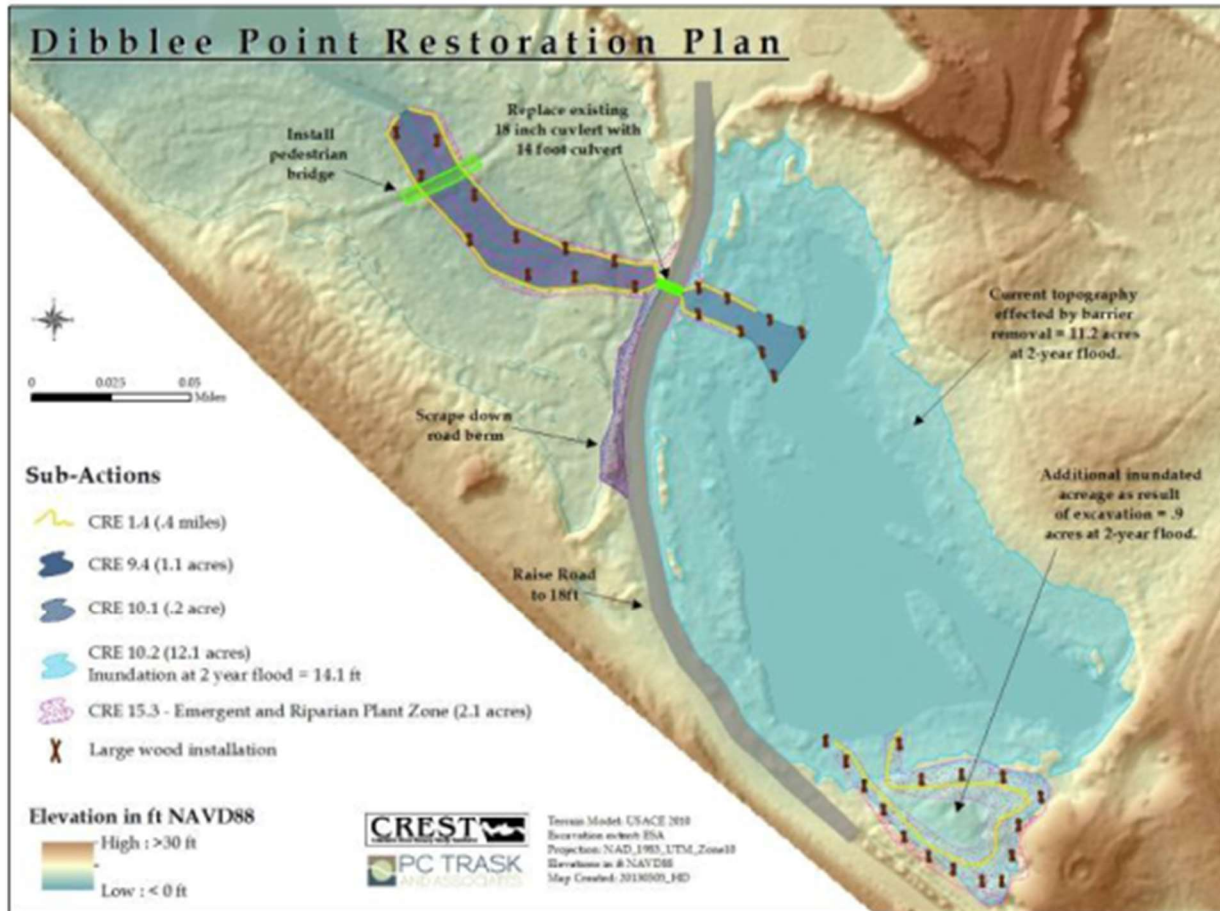
Figure 16: Dibblee Point restoration plan (Courtesy: Tom Josephson, CREST)

1. Excavating 250m of a new channel, creating full tidal access to the shallow habitats.
2. Large wood installations and native plantings in the newly created marshplain.
3. Installation of a 14ft wide culvert under roadway

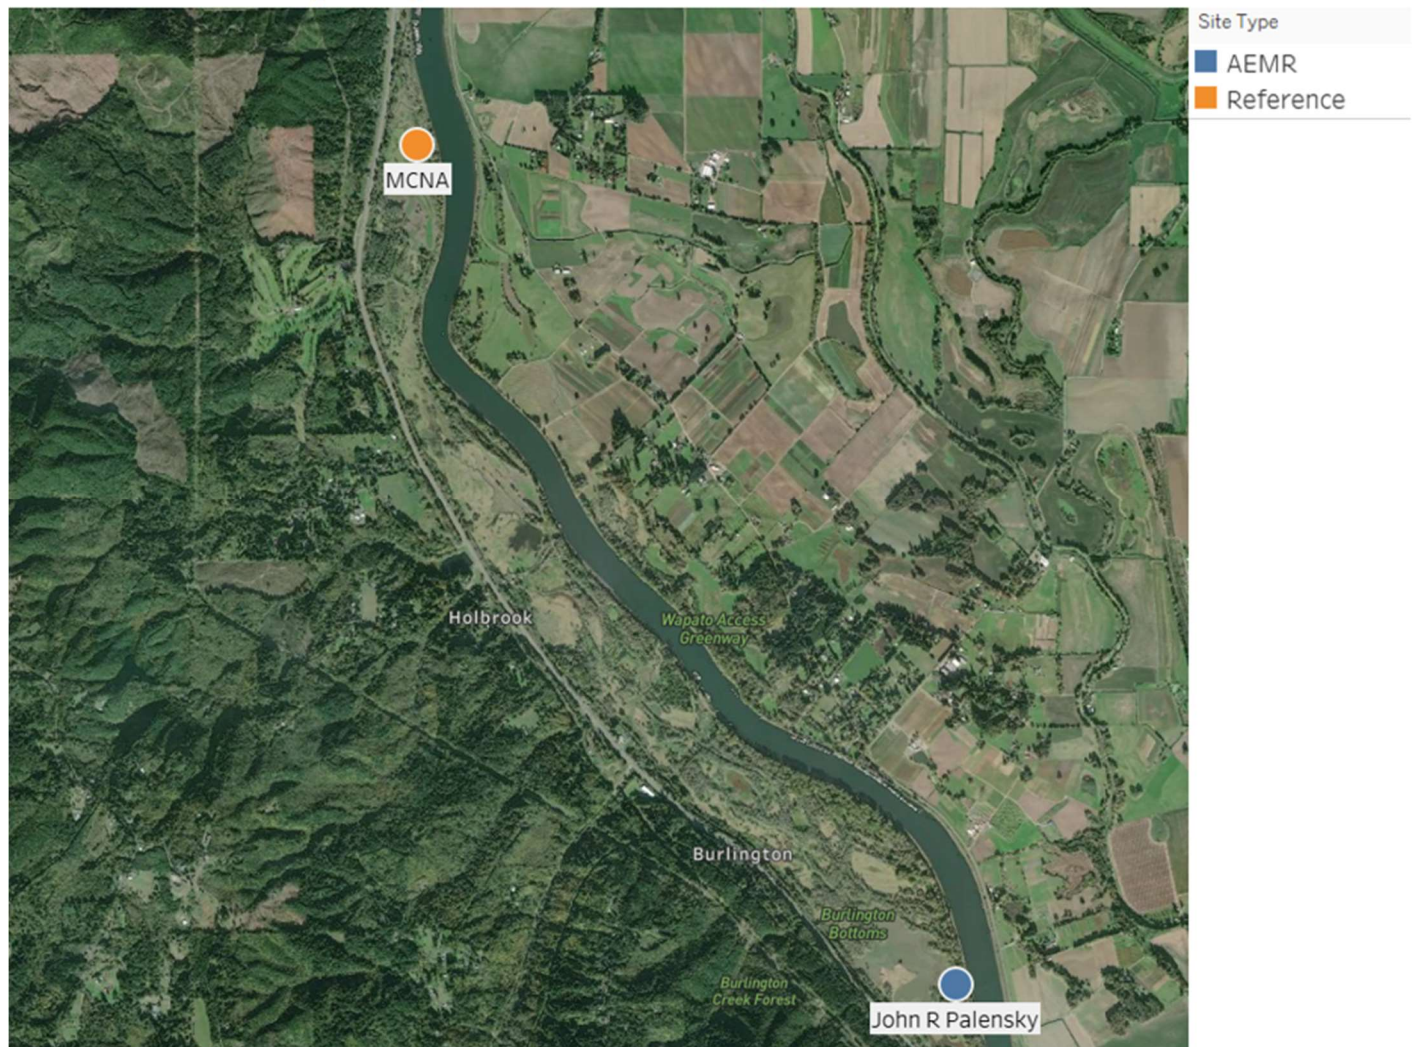
Figure 22: Overview map of the JR Palensky wetland and reference MCNA.

## John R Palensky Project Overview Map

Palensky has received monitoring since 2021. In 2021, pre-construction monitoring was conducted by establishing 4 vegetation survey transects (2 at Snipe Lake and 2 at Bur Reed Lake). Six pairs of sed stakes were installed in Bur Reed Lake in 2021 and Multnomah Channel Natural Area (MCNA), located to the north of Palensky, was included in the study as an unimpacted reference site (Figure 22).

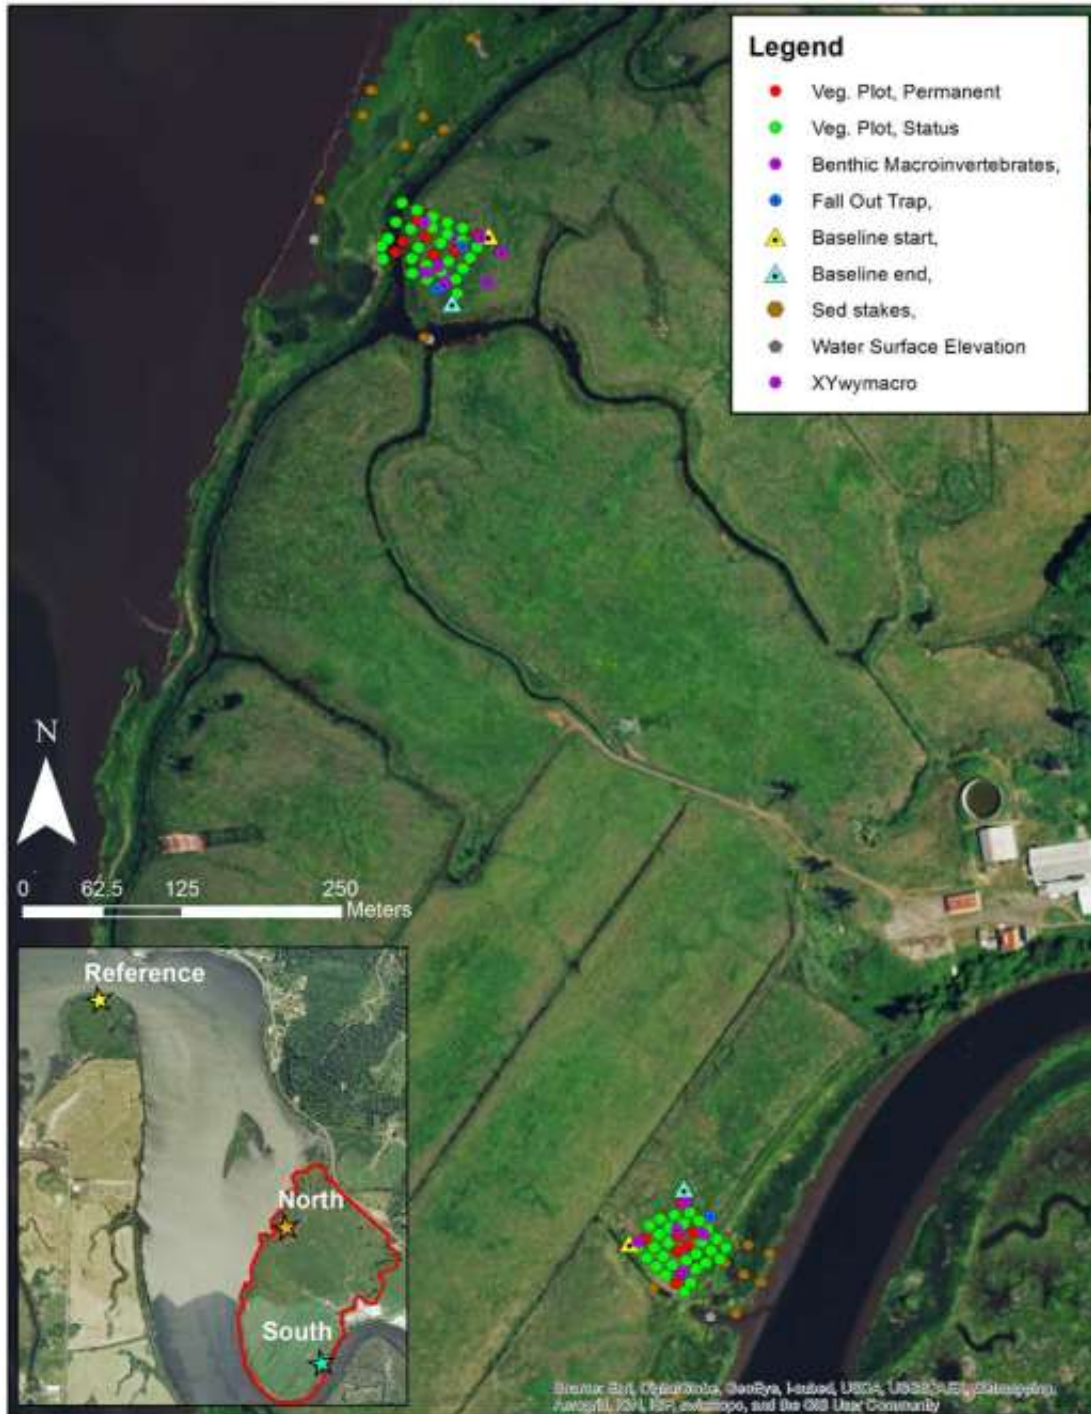
Figure 23: Vegetation and macroinvertebrate sampling locations at the Wallooskee-Youngs Restoration site (Fallout traps from 2015 – 2018, Neuston Tows in 2020).

- Located in area between the culvert removal and dike breach
- 60 m x 60 m, with 36 quadrat locations
- Baseline azimuth: 29° magnetic
- Transect azimuth: 119° magnetic
- Transect spacing: 10 m, random start: 1
- Quadrat spacing: 10 m, random starts: 8, 6, 1, 3, 9, 6

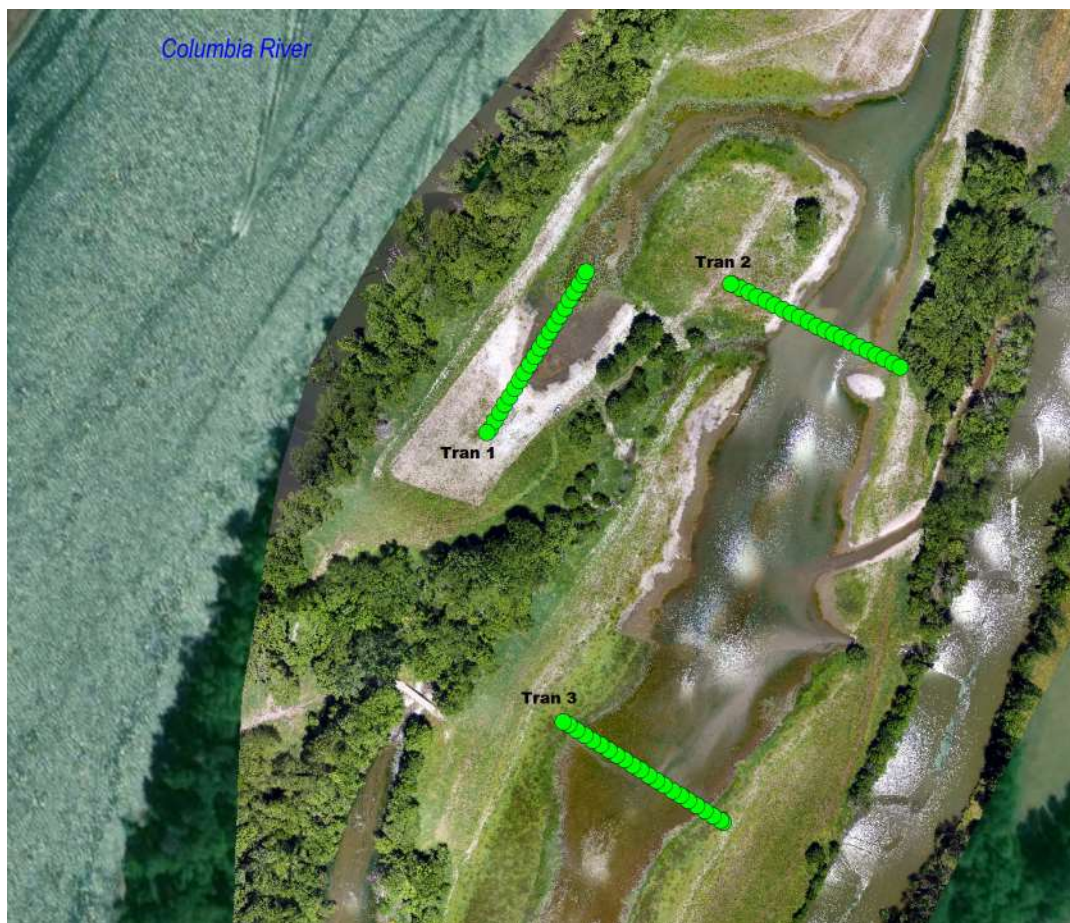
Figure 25: Vegetation sampling locations at the Flights End restoration site

- *Vegetation*: Herbaceous cover (3 sample transects of 20 quadrats, 60 quadrats total)
- *Elevation*: collected elevation at all vegetation quadrats
- *Sed Benches*: One pair of sed stakes (Flights\_End\_SED\_1) was measured. SED\_2 was not found in 2018. A third set was installed for 5-year post. Usually surveyed by CREST.

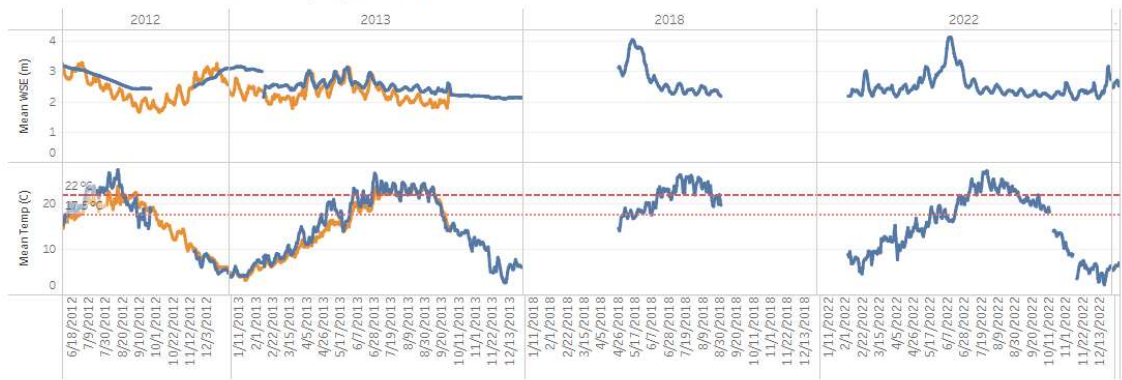
**Mean Daily Water Surface Elevation, Temperature, and Salinity**  
Dibblee Point restored in 2013. 2022 marks 10 years post-restoration

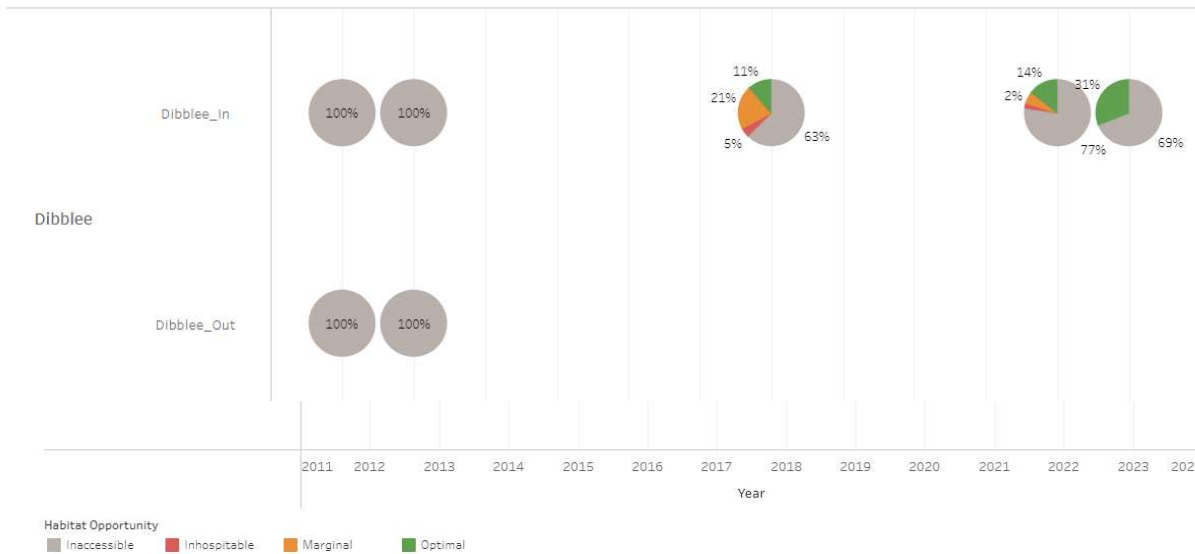
**Salmonid Habitat Opportunity**

**Results:** Prior to restoration, Dibblee Point was inaccessible for most of the year. After restoration, habitat opportunity at the site increased overtime to 31% in 2022. This could be attributed to the consistently high summer time temperatures that are above 22 °C at Dibblee Point.

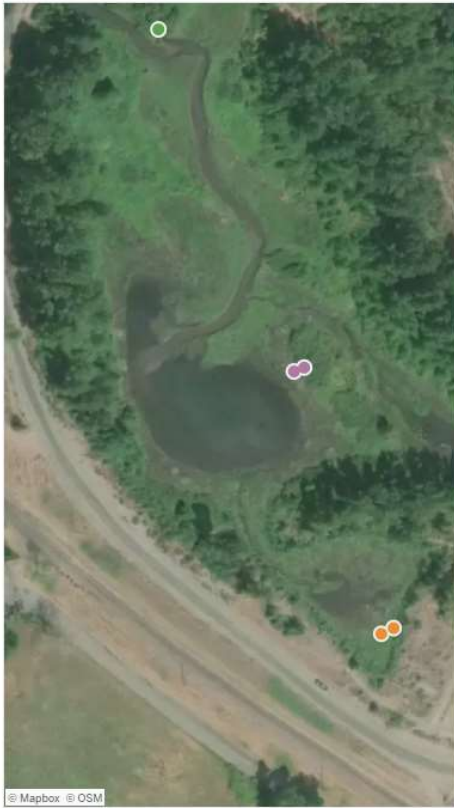
Sediment Accretion and Erosion Monitoring - Overview Map

Marsh Location  
High Marsh Low Marsh Mid Marsh

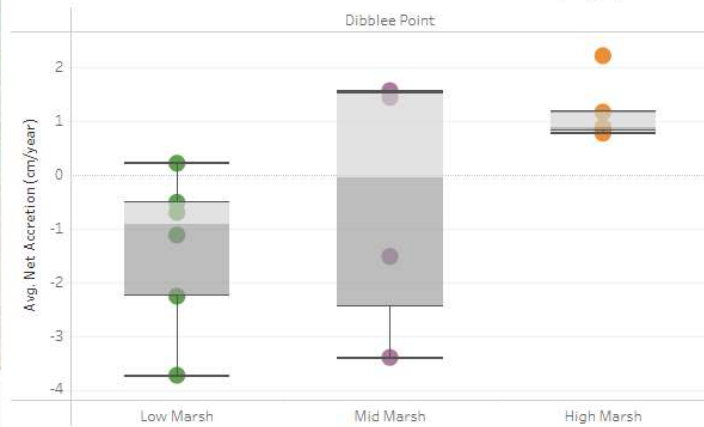
Normalized change in elevation is the amount of elevation gained (accretion) or loss (erosion) from the first year of the survey period. Average Net Accretion is the rate at rate at which this change takes place in cm/yr.

Marsh Location - Site Accretion and Erosion - Accretion Rate (cm/yr)

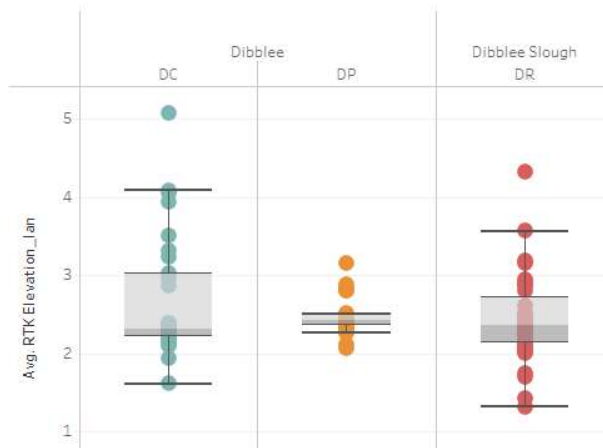
**Results:** Soil conditions were monitored for the first time in 2022 at two locations in Dibblee Point - Dibblee Channel (DC) - located outside the culvert in the excavated channel and Dibblee Pond (DP) - located on the other side of the culvert. Soil conditions were also monitored at Dibblee Reference (DR) in 2022. Generally, soil conditions were pretty similar accross all three monitoring locations. Soil temperature was slightly elevated in Dibblee Pond.

Site Elevations

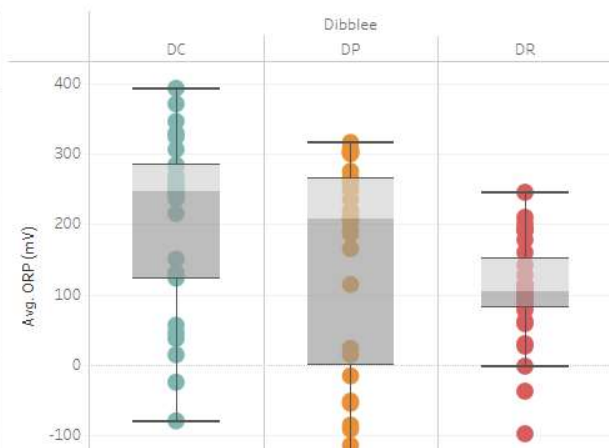
ORP

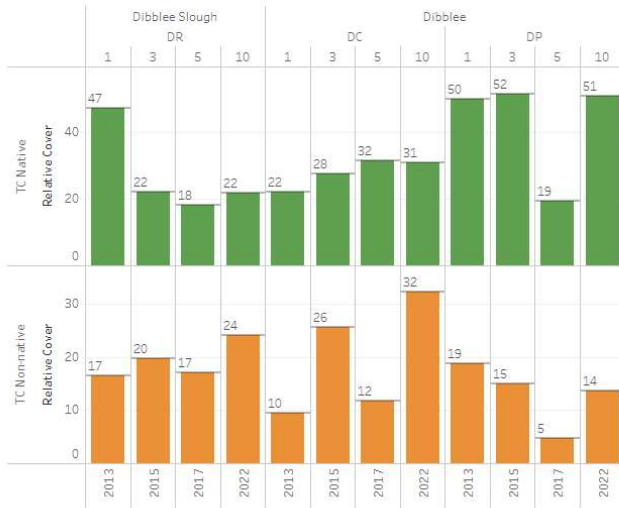
#### Relative Cover By Native Status

Results: The vegetation development at Dibblee Point shows a healthy ratio of native cover at year 10 post-restoration. Dibblee Pond has a native cover of 51% while Dibblee Channel has a native cover of 31%. Overall living cover at the resto has increased in 2022, eventhough a large amount of bareground exists at Dibblee

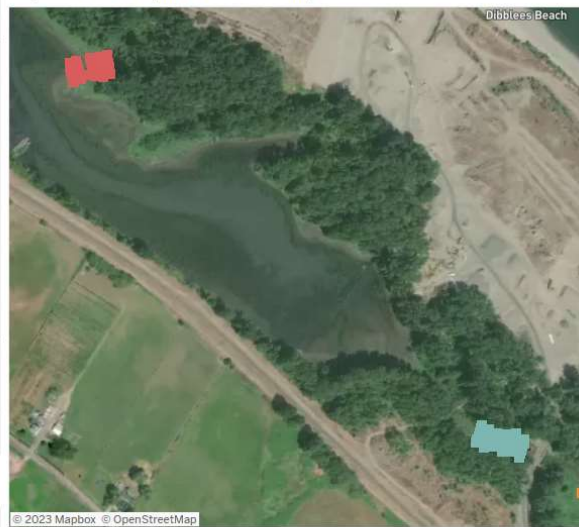
#### Vegetation Development Overview Map

Site ID NEW  
 DC DP DR

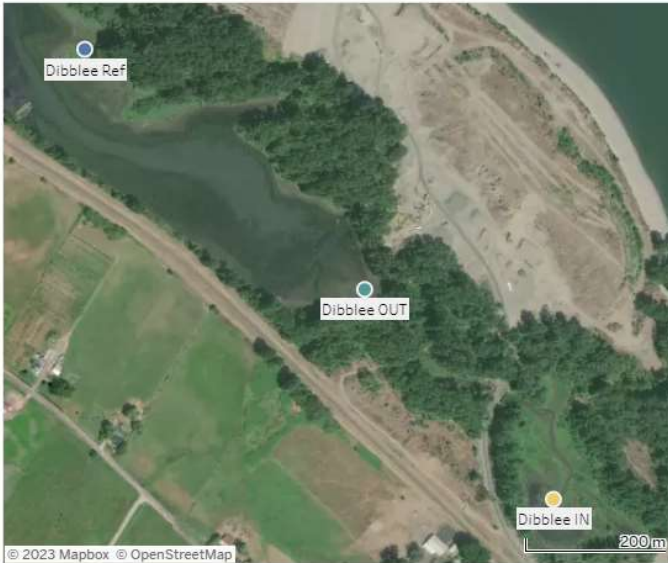
## Overview Map of Macroinvertebrate Sampling Locations

**Results:** Salmon prey abundance has steadily increased between 2013-2022 at Dibblee Point, and in 2022, the restoration site had significantly larger abundance of macroinvertebrates in comparison to the reference site. Until 2017, Collemba was dominant, however, in 2022 Cladocera was dominant. This change could be attributed to change in sampling methodology.

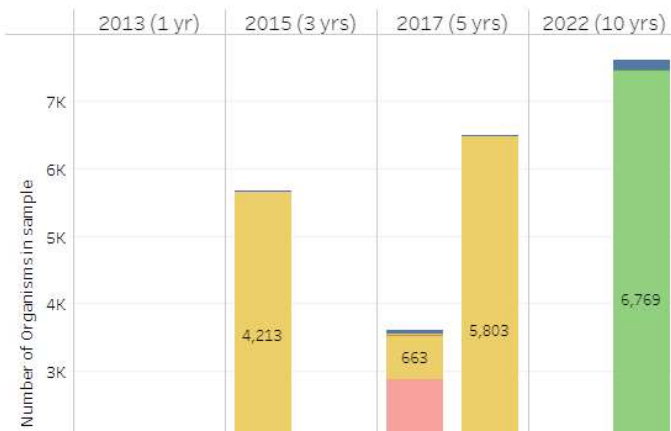
Total Abundance of Macroinvertebrates

Beginning in 2020, the sampling methods were altered to Nueston Tows. At each site, 2 Nueston tows were deployed at the edge of the wetland channel among vegetation in May. Samples were combined into one composite sample and preserved in 95% ethanol.

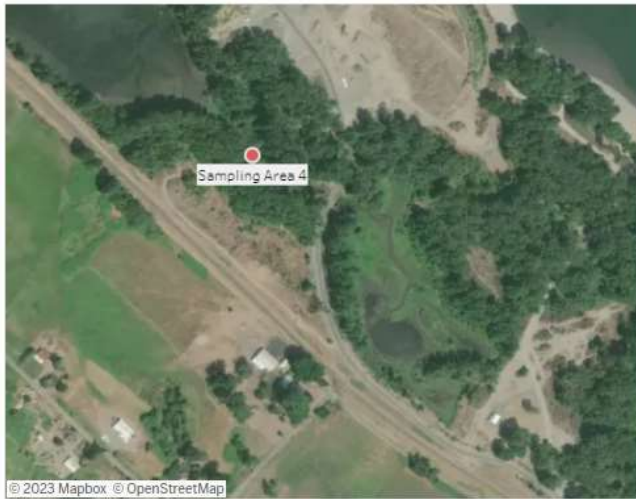
## Fish Sampling Map

All non-salmonid fish were identified to the species level counted and released. Sampling was conducted only in April, as water temperatures were too high in May and July 2022. All salmonids were measured (fork length, nearest mm), checked for adipose fin clips, or other external marks, coded wire tags, and passive integrated transponder tags to distinguish between marked hatchery fish and unmarked (presumably wild) fish and released. A Genetic sample was taken from the caudal fin on all captured Chinook salmon. Temperature in degree Celsius and Dissolved Oxygen (DO, mg/l) was measured.

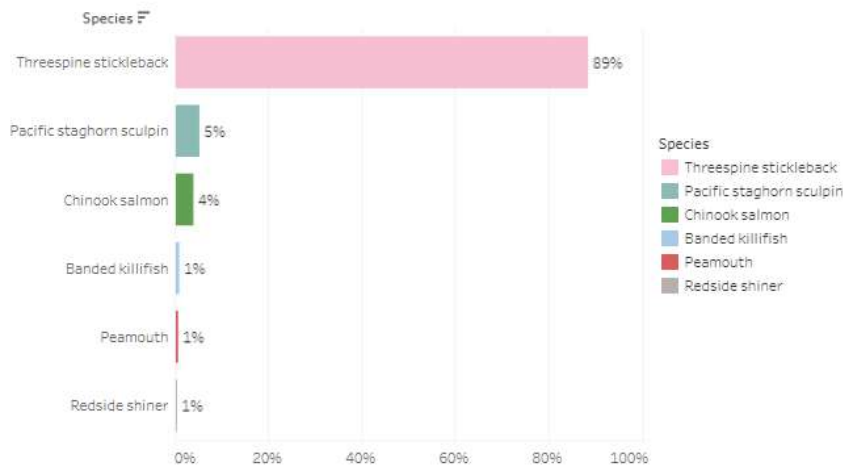
**Results:** Majority of the community sampled at Dibblee Point consisted of Non-salmonids. Threespine stickleback made up 89% of community composition. 4% of the community was comprised of Chinook Salmon, indicating that other salmonids use the site.

Fish Community Composition at Year 5 Post-restoration
