# Wetland Reference Sites in the Lower Columbia River and Estuary: Status, Trends, and Applications

Amy B. Borde, Heida L. Diefenderfer, Valerie I. Cullinan, Ronald M. Thom, Shon A. Zimmerman, and Ronald M. Kaufmann

Columbia River Estuary Conference  
Astoria, Oregon  
May 16, 2012

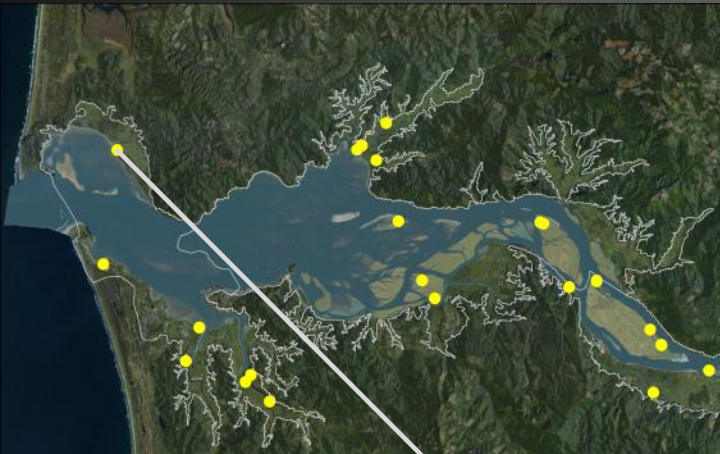
# Study Sites

- ▶ Tidal influence
- ▶ River flows
- ▶ Power peaking
- ▶ Seasonal variability
- ▶ Inter-annual variability

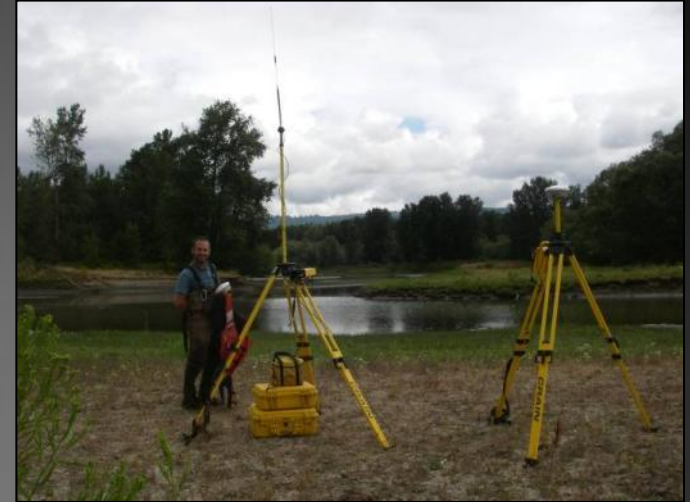
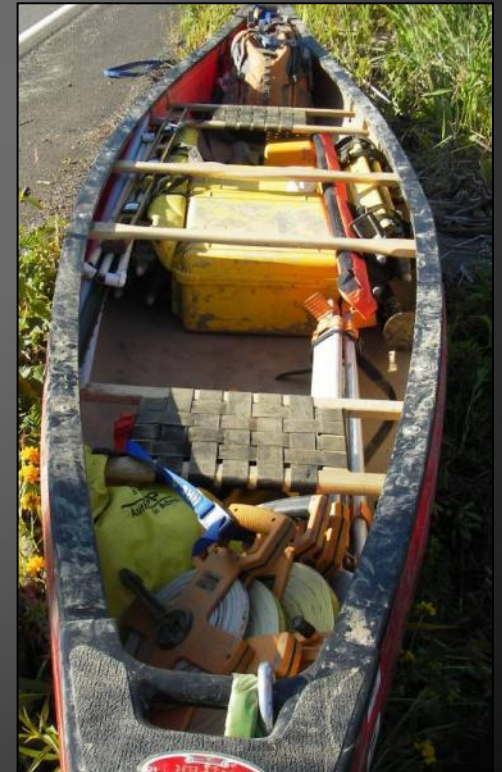
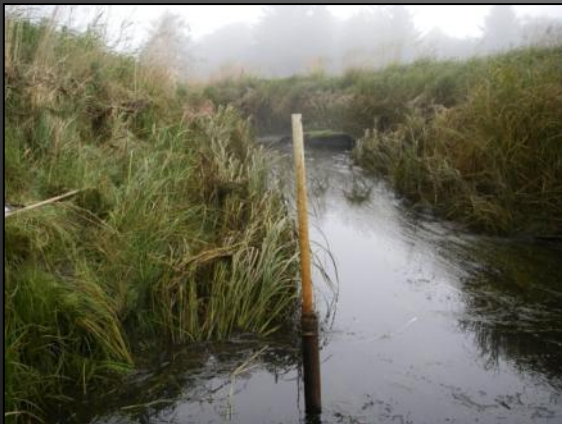
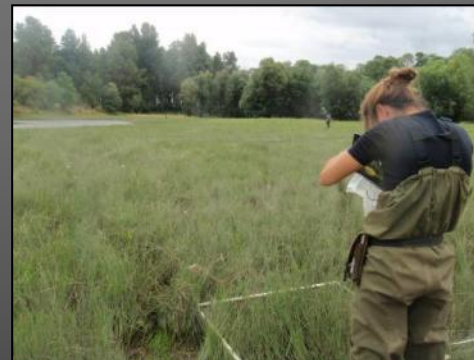
# Metrics

- ▶ Vegetation percent cover surveys
- ▶ Vegetation community mapping
- ▶ Elevation collected with Real Time Kinematic (RTK) GPS, with auto level for areas of high tree cover
- ▶ Referenced to NAVD88
- ▶ Water level sensors were surveyed to evaluate hydrology relative to wetland morphology

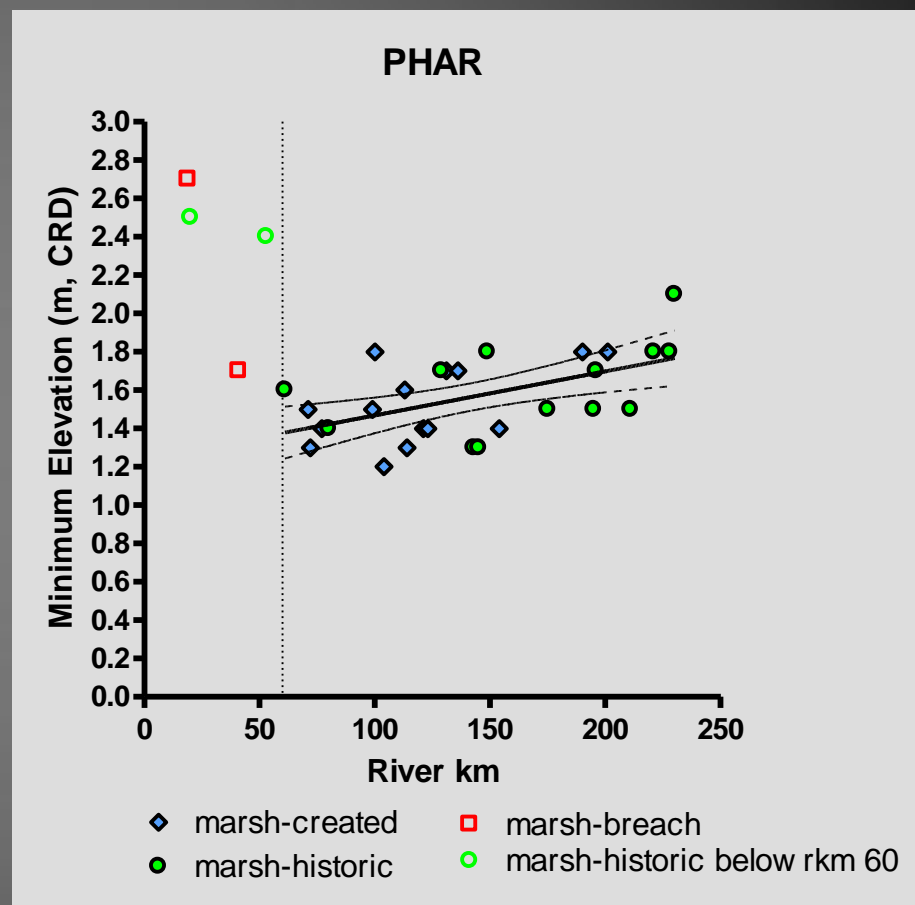
# Elevation

▶ Average minimum elevation where PHAR was the maximum cover species ranged from 1.4 to 1.7 m, CRD with 95% CI of 1.2 to 1.8 CRD

▶ Below 1.5 m, CRD

- *Eleocharis*
- *Sagittaria*

were the species most often observed with maximum cover

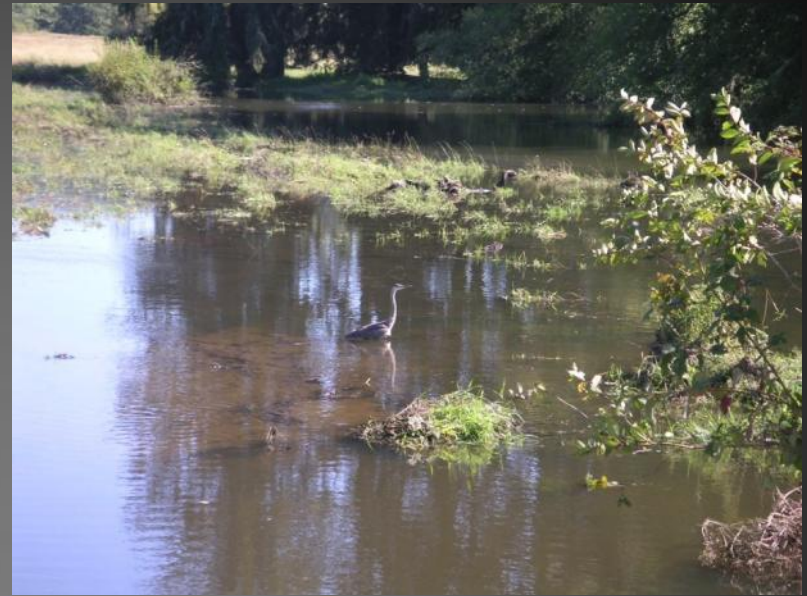
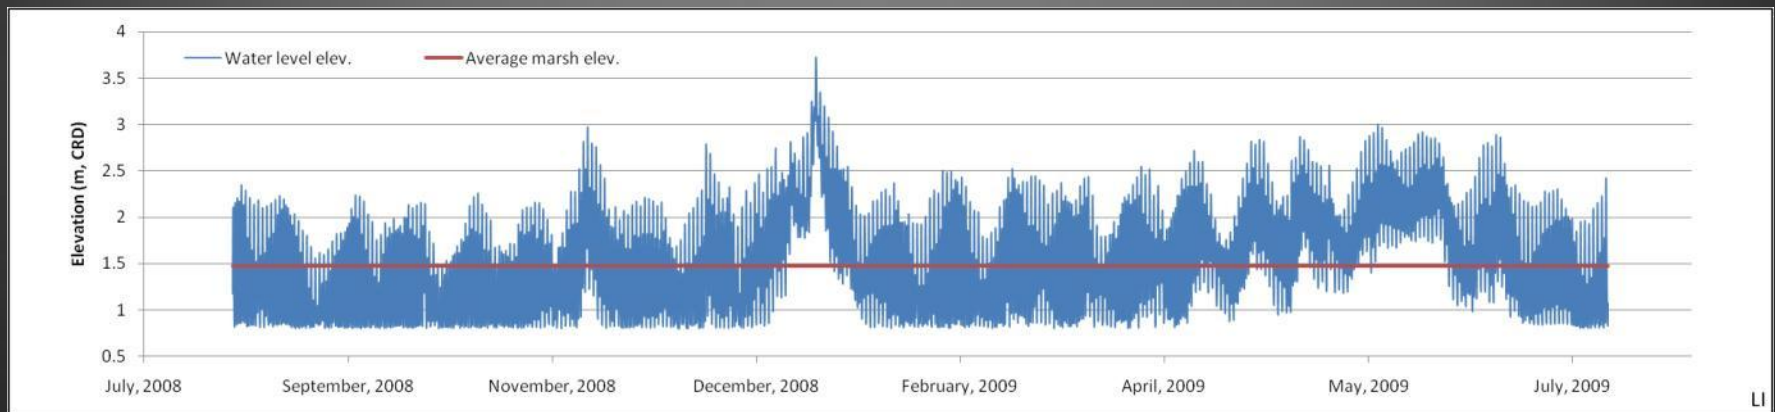
## Sum Exceedance Value

$$SEV = \sum_{i=1}^n (d_{\text{elev}})$$

$d$  = daily water elevation  
above a marsh elevation

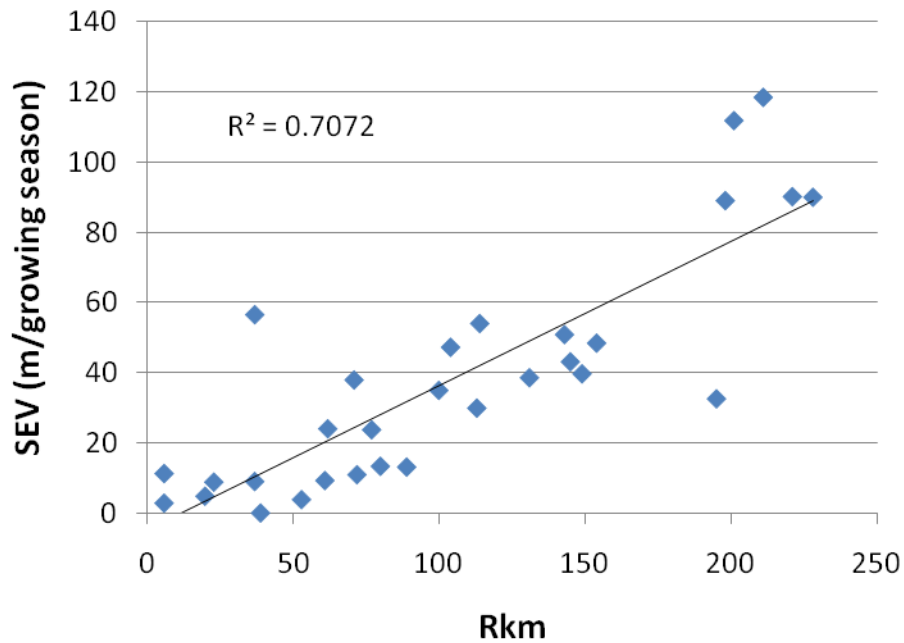
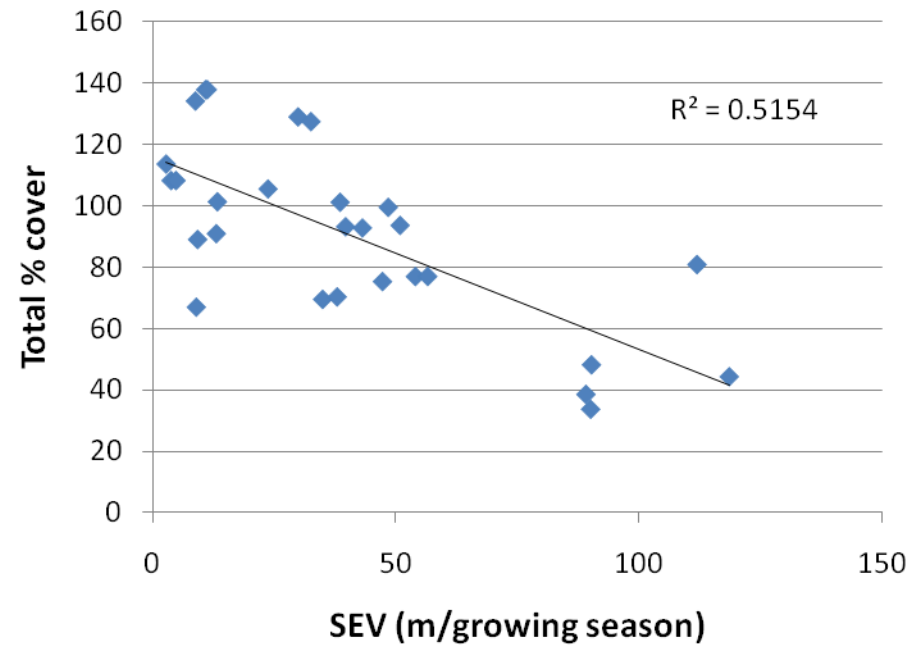
Inundation increases with Rkm

Total vegetated cover decreases with increasing inundation

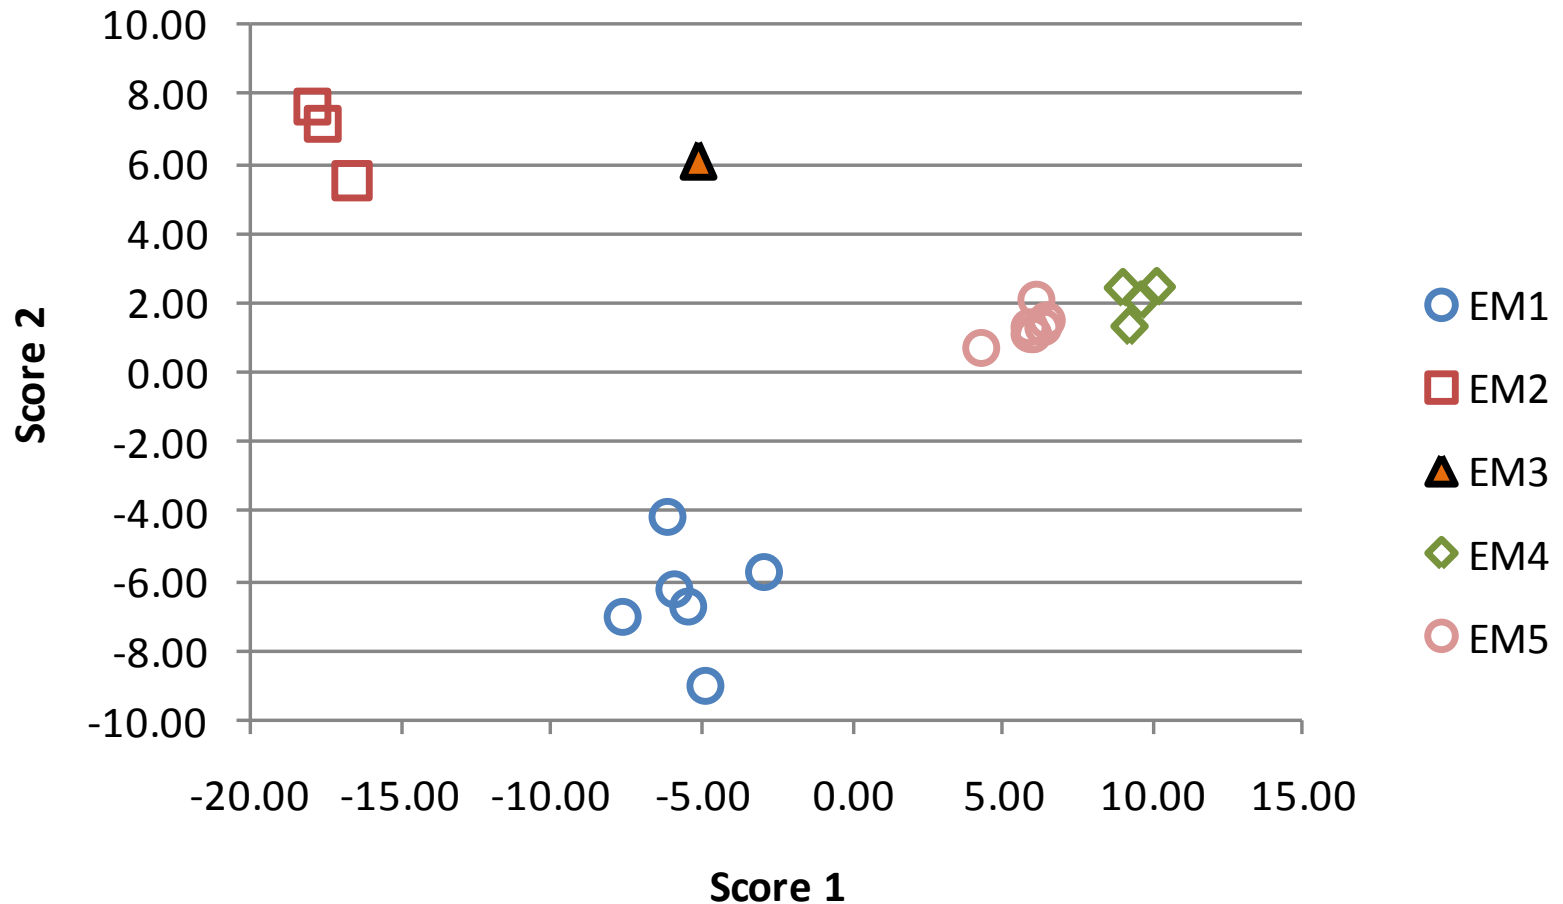
# Vegetation Distribution

- ▶ Analysis based on 20 historic marsh sites
- ▶ 13 vegetation species (out of 220)
- ▶ Discriminant Function Analysis

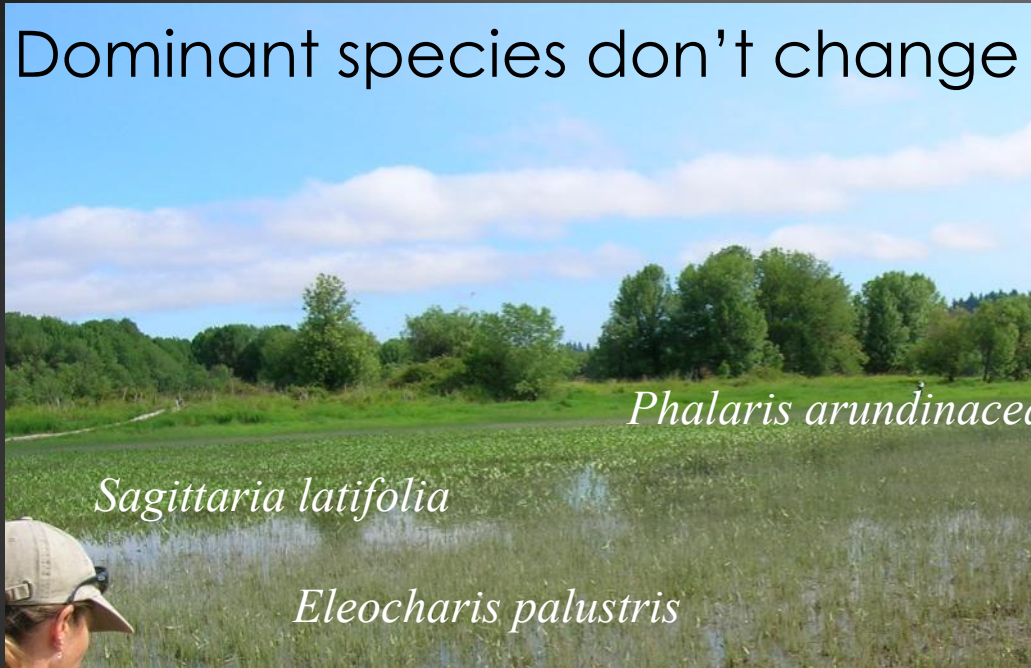
# Temporal Variability

Dominant species don't change

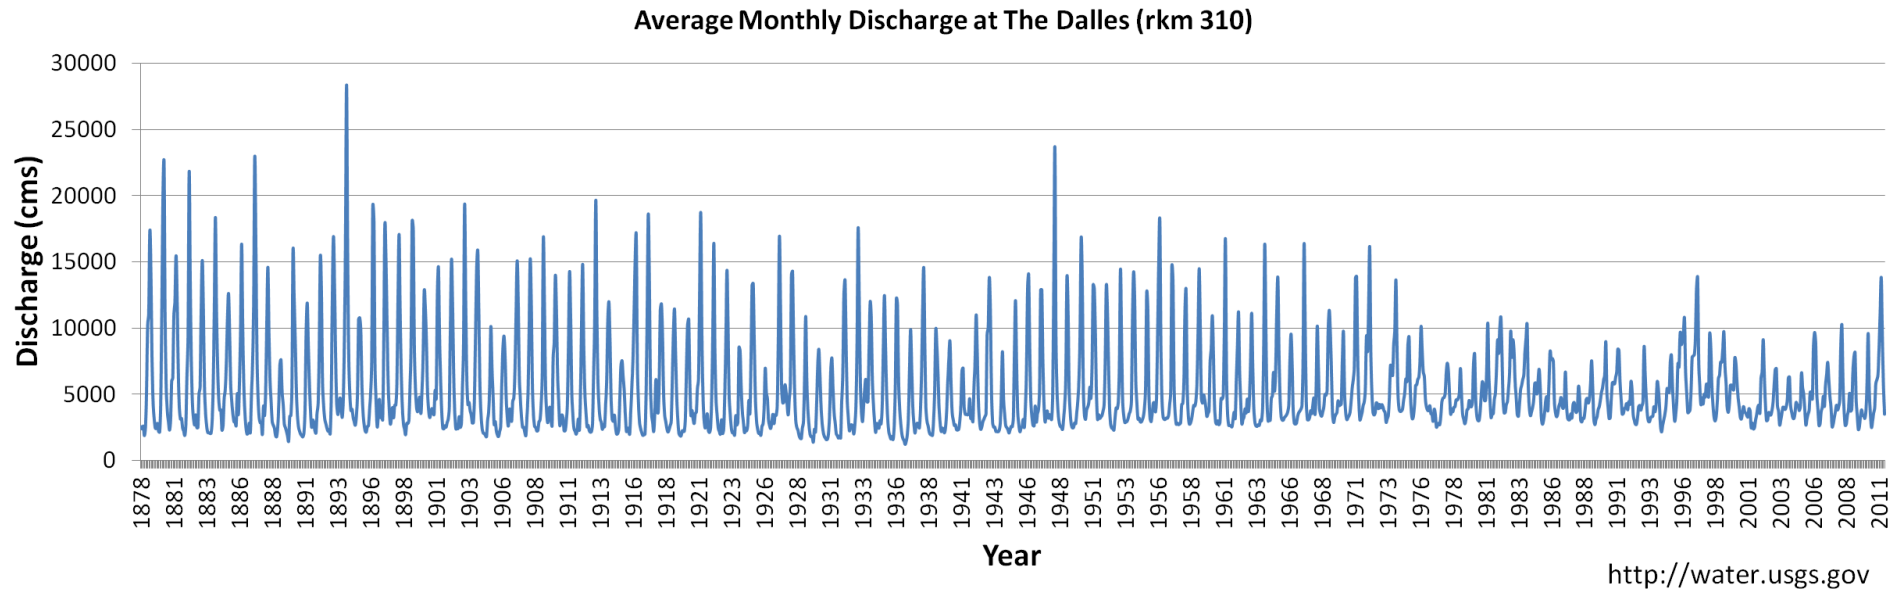
- ▶ Examine how inundation patterns have changed in the past 130 years
