Action Effectiveness Monitoring and Research Spectacular

Science Work Group Meeting - March 26, 2019

Programmatic Action Effectiveness Monitoring

Columbia Estuary Ecosystem Restoration Program (CEERP) Objectives

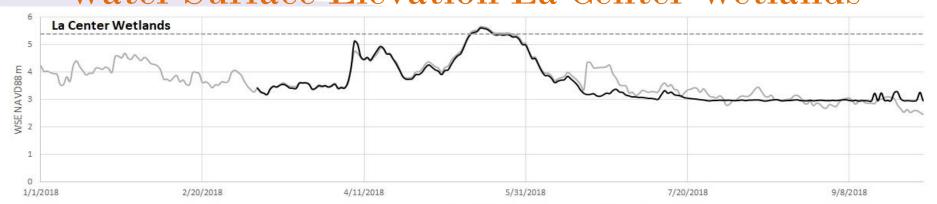
Water Surface Elevation La Center Wetlands

2											
0 1/1/2018	2/20/2018		4/11/2018 —— Outer Reference		Restoration S	//31/2018 Site 2-1	yr flood elevatio	7/20/2018 r flood elevation			
	Month	Jan	Feb	Mar	Apr	May	Jun	Jul	Aug	Sep	Oct
	n (days)			23	30	31	30	31	31	30	4
p	Mean Max			3.47	4.20	4.96	3.63	3.09	2.99	3.03	3.03
Restored	Days Exceeded 2 yr Flood Elevation	0	0	0	0	8	0	0	0	0	0
ance	n (days)	31	28	31	30	31	30	31	31	30	4
Reference	Mean Max	4.16	3.86	3.53	4.19	5.04	4.01	3.31	3.04	2.86	2.58

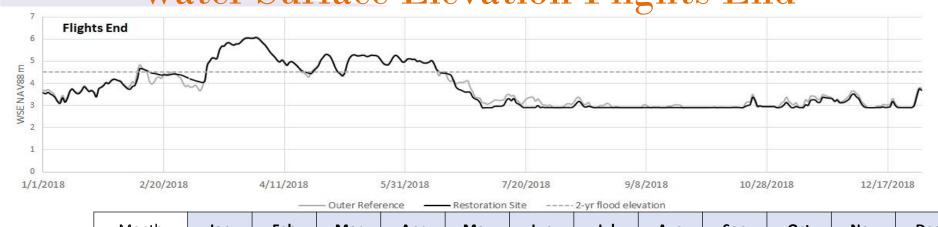
Water Surface Elevation Flights End

MSE NAV	~	~						<u></u>	~	~~\			
1 0 1/1/2018	2/20/2018	4/11/2018				7/20/2018 — Restoration Site		9/8/2018 2-yr flood elevation		10/28/2018		12/17/2018	
	Month	Jan	Feb	Mar	Apr	May	Jun	Jul	Aug	Sep	Oct	Nov	Dec
Restored	n (days)	31	28	31	30	31	30	31	31	30	31	30	31
	Mean Max	3.64	4.29	5.23	5.02	5.03	4.37	2.99	2.94	2.91	2.96	3.11	3.08
	Days Exceeded 2 yr Flood Elevation	0	5	22	28	28	14	0	0	0	0	0	0
a	n (days)	31	28	31	30	31	30	31	31	30	31	30	31
