EMP mainstem conditions: in situ observations

Joseph Needoba

Biogeochemical Platforms

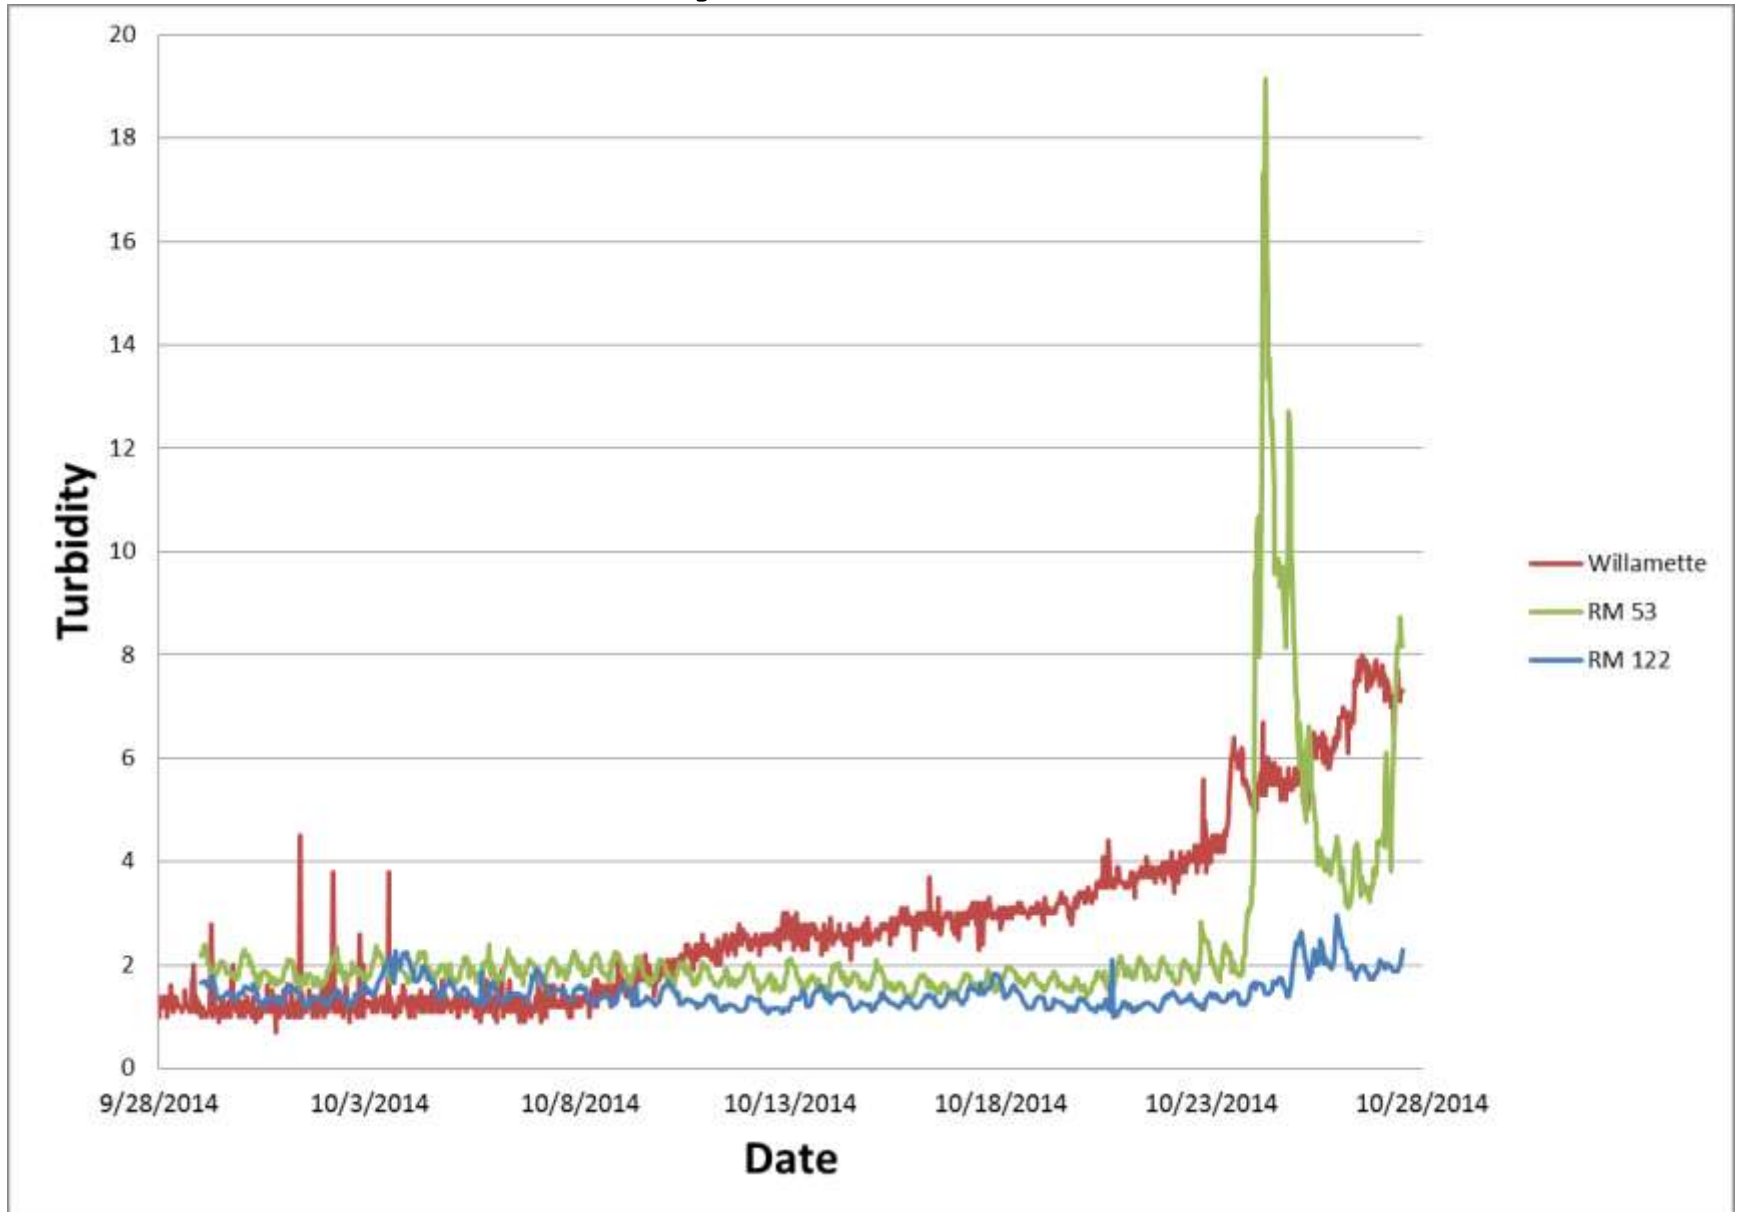
Turbidity at 3 locations

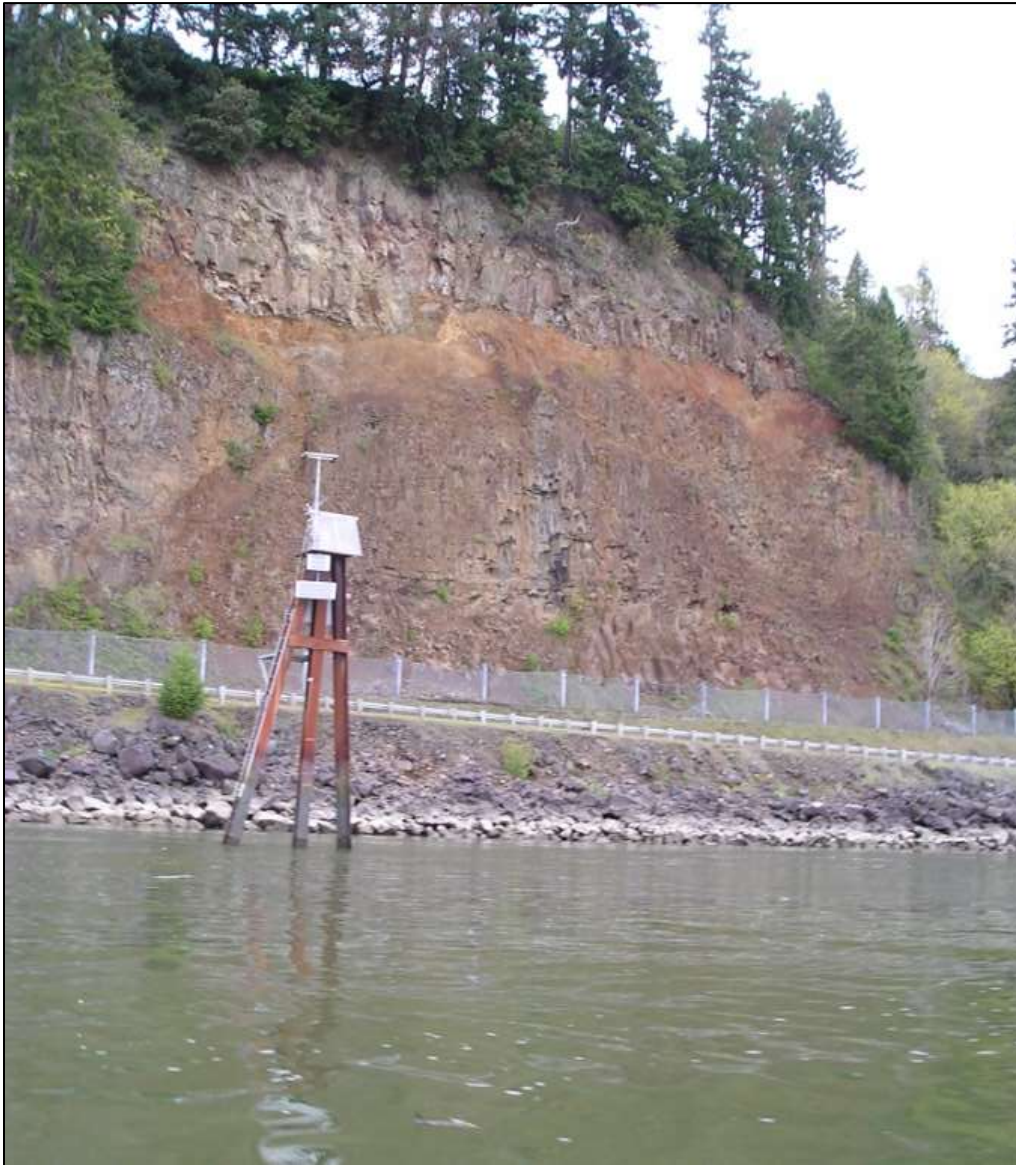
RM-53 Platform Design

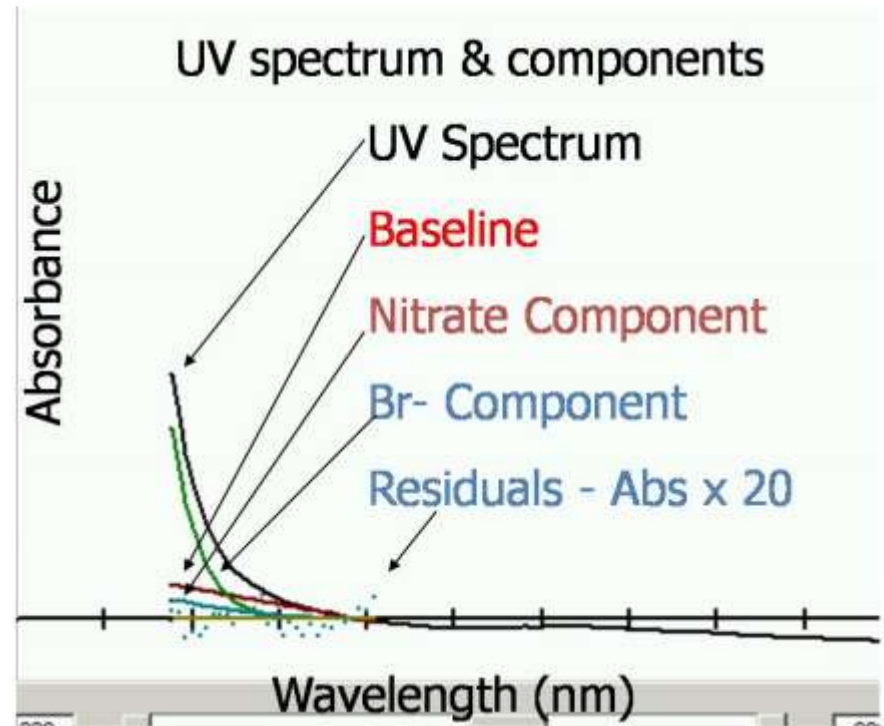
- ISUS (In Situ Ultraviolet Spectrophotometer)
- Optical sensor for NO_3^-

ISUS sensor with anti-fouling filter

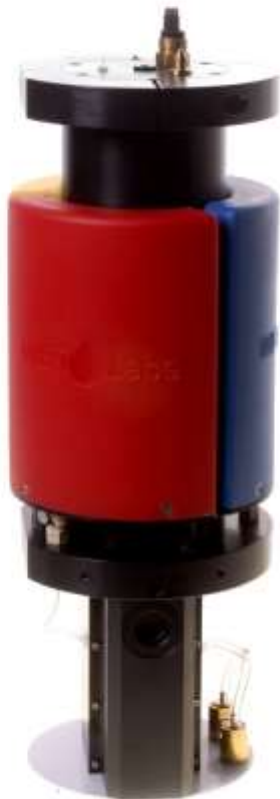
Phosphate Sensors

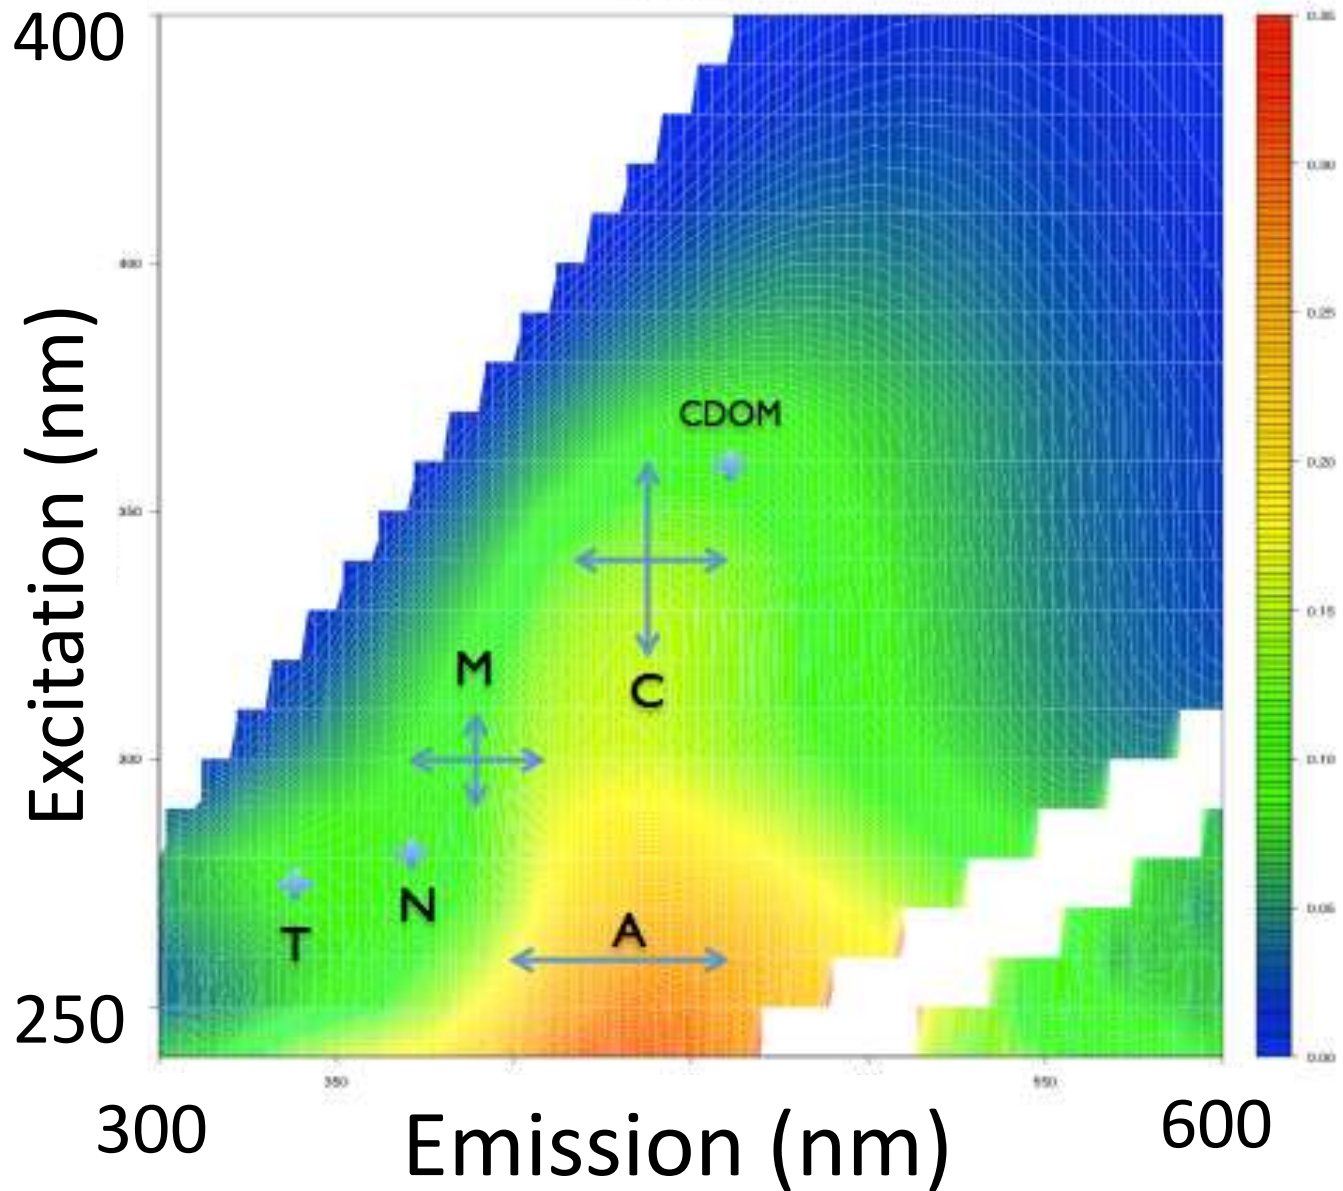
CDOM sensor
